BIOPHYSICAL MONITORING: REPORT 1 OF THE UPPER TSITSA RIVER CATCHMENT (T35 A-E)

TSITSA PROJECT

Huchzermeyer, N; Schlegel, P; van der Waal, B

August 2019

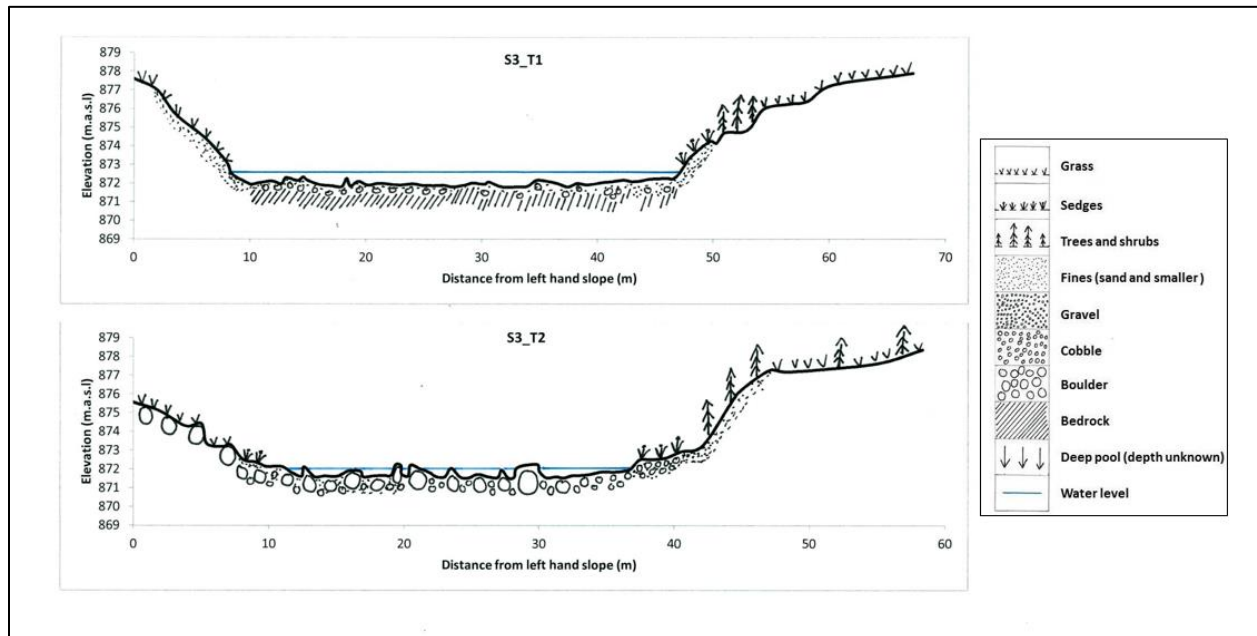
FIGURE 19: CROSS-SECTIONAL TRANSECTS, INCLUDING DISTRIBUTION OF SUBSTRATES, GEO-HABITATS AND JULY 2015 WATER LEVELS, FOR SITE NH3 (HUCHZERMEYER, 2017)

Cross-sectional profiles show the current morphology of the river channel. This is shaped by the current flow hydraulics and sediment inputs (Brandt, 2000; Apitz, 2012). Cross-sectional profiles provide a comprehensive depiction of the current physical structure of river sites (Figure 19). Geo-habitats are habitat features that are directly linked to the physical structure of the channel (Rowntree, 2013).

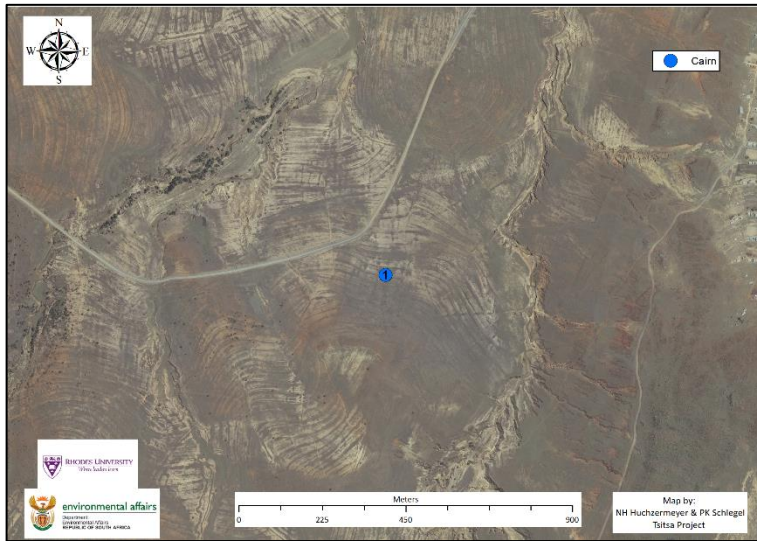
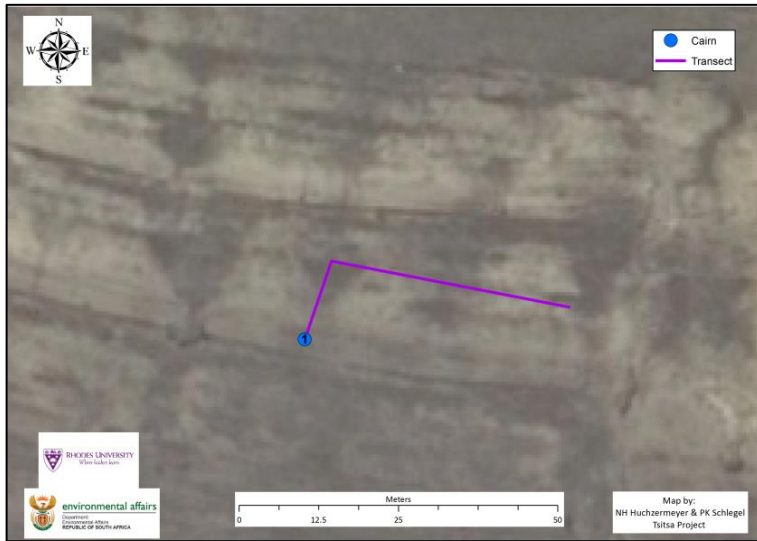
FIGURE 41: LOCATION OF VELD MONITORING SITE 1

Veld monitoring Site 1 is located on an abandoned cultivated land and used by local livestock for grazing (Figure 41). The veld condition is poor due to the dominance of poor grazing grasses and very poor ground cover. Table 16 summarises the condition at Site 1 as well as the current grazing potential.

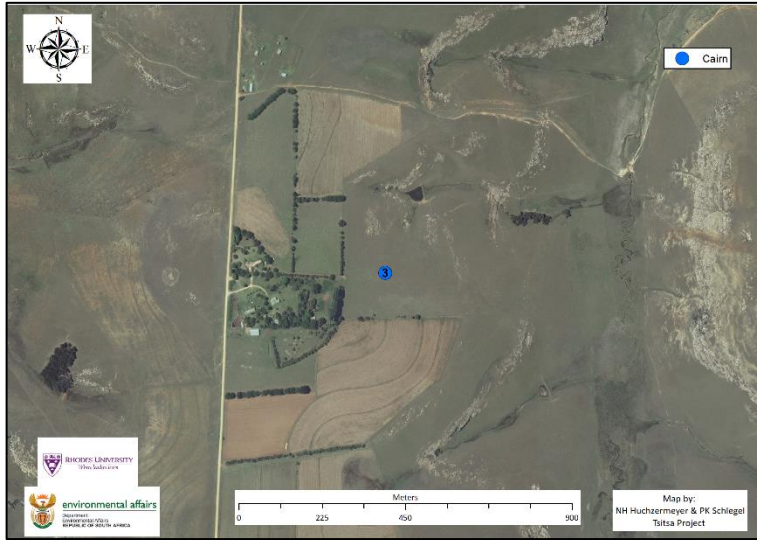
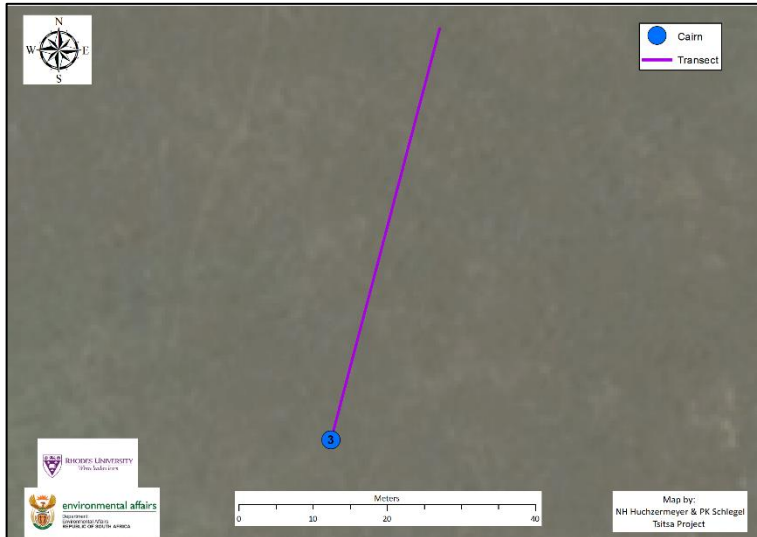
FIGURE 50: LOCATION OF VELD MONITORING SITE 3

Site 3 is situated in a grazing camp on a private farm (Figure 50). Table 18 summarises the veld condition at Site 3. It exhibits a moderate veld condition and a large proportion of the grass present is grass with a good grazing value. However, over utilisation and reduction in ground cover and biomass is reducing the veld condition score.

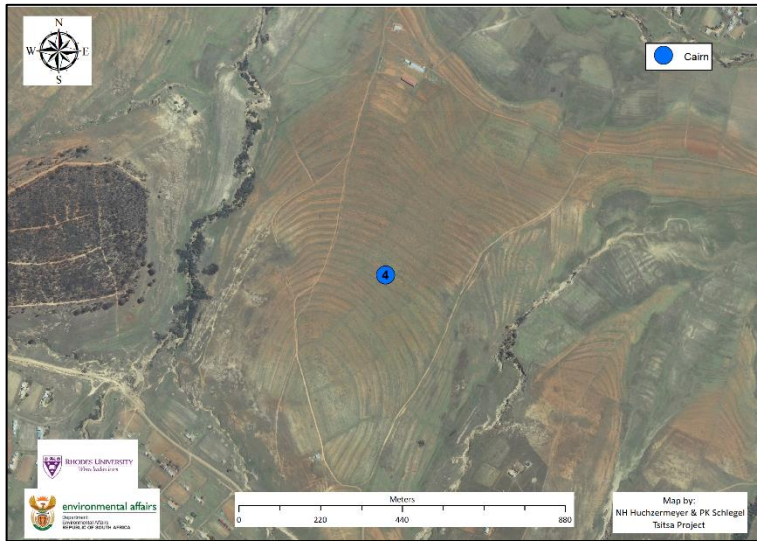
FIGURE 54: LOCATION OF VELD MONITORING SITE 4

Site 4 is situated on an abandoned field and is used as grazing lands for cattle (Figure 54). Table 19 summarises the condition of Site 4. It is heavily utilized and shows poor biomass and ground cover and is dominated by grasses with poor grazing potential and an abundance of unpalatable forbs. Site 4 has a very poor veld condition with moderate levels of topsoil loss contributing to the sustained degradation of this grazing land.

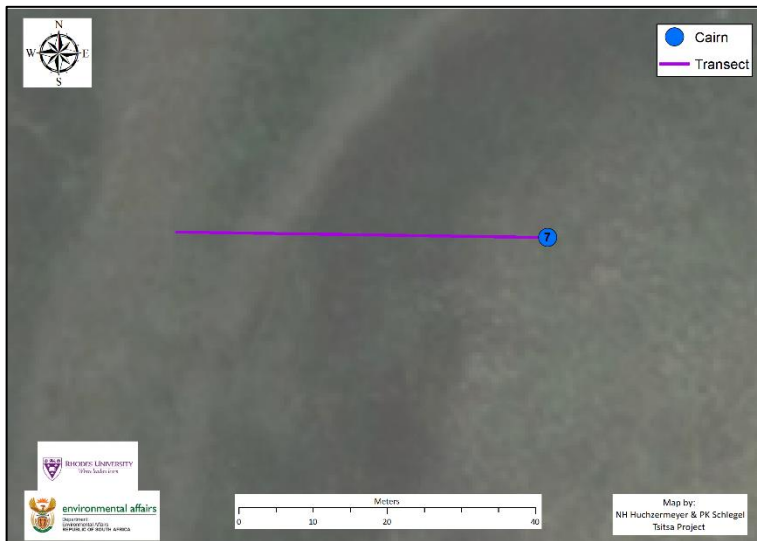
FIGURE 69: LOCATION OF VELD MONITORING SITE 7

Site 7 occurs in a valley close to an un-channeled valley bottom (Figure 69) and provides winter grazing to livestock. Table 22 summarises the veld condition at site 7. This area has good groundcover and biomass most likely to its location in the landscape but it also exhibits grasses with lower than average grazing potential.

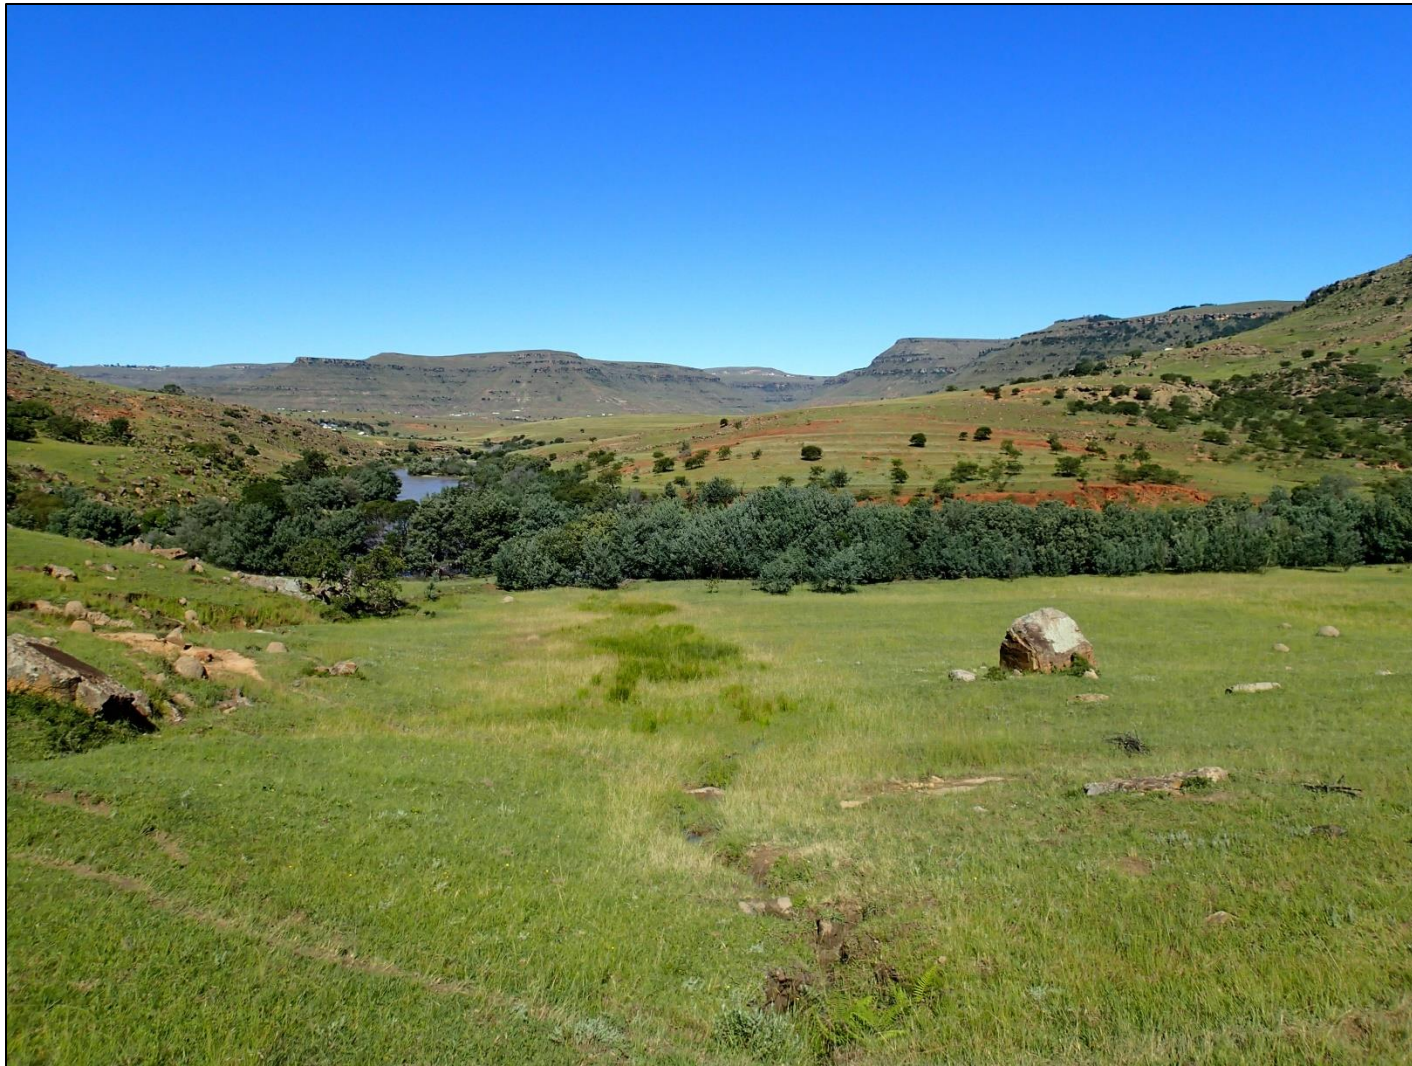
Figure 80 shows the current condition of Wetland 1 exhibiting good vegetation cover and alien invasive trees at the toe of the wetland.

FIGURE 80: LANDSCAPE PHOTOGRAPH OF WETLAND 1. PHOTO TAKEN AT 12H00 ON THE 26/04/201

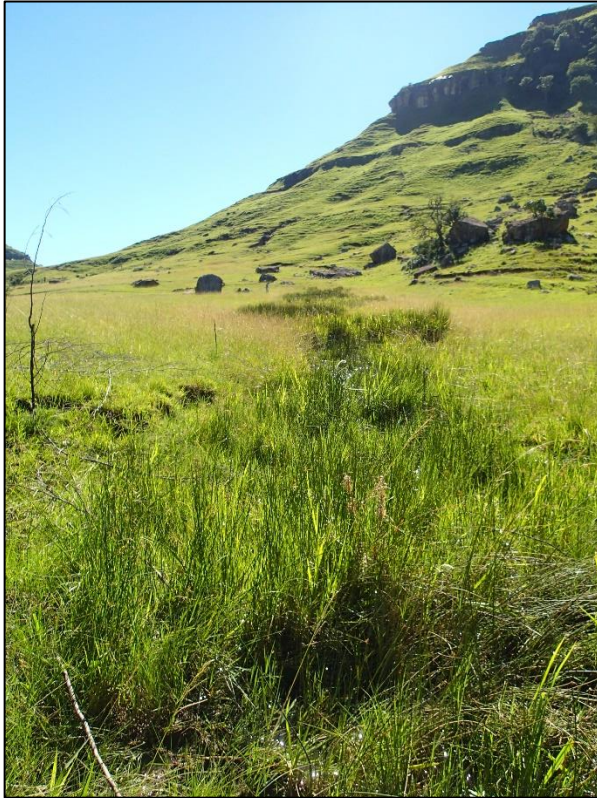
Figure 81 shows the view up the wetland from the toe to the head. The steep catchment is visible in the background and it is clear that the wetland is forming on the lower gradient slopes of the Tsitsa River floodplain. Figure 82 shows how natural vegetation is suppressed by alien invasive trees (*Acacia dealbata*) resulting in an erosional nickpoint at the toe of the wetland where the wetland seeps into the Tsitsa River.

FIGURE 81: VIEW FROM THE TOE OF WETLAND 1 SHOWING THE STEEP CATCHMENT ABOVE AND LOWER GRADIENT ON THE FLOODPLAIN BELOW

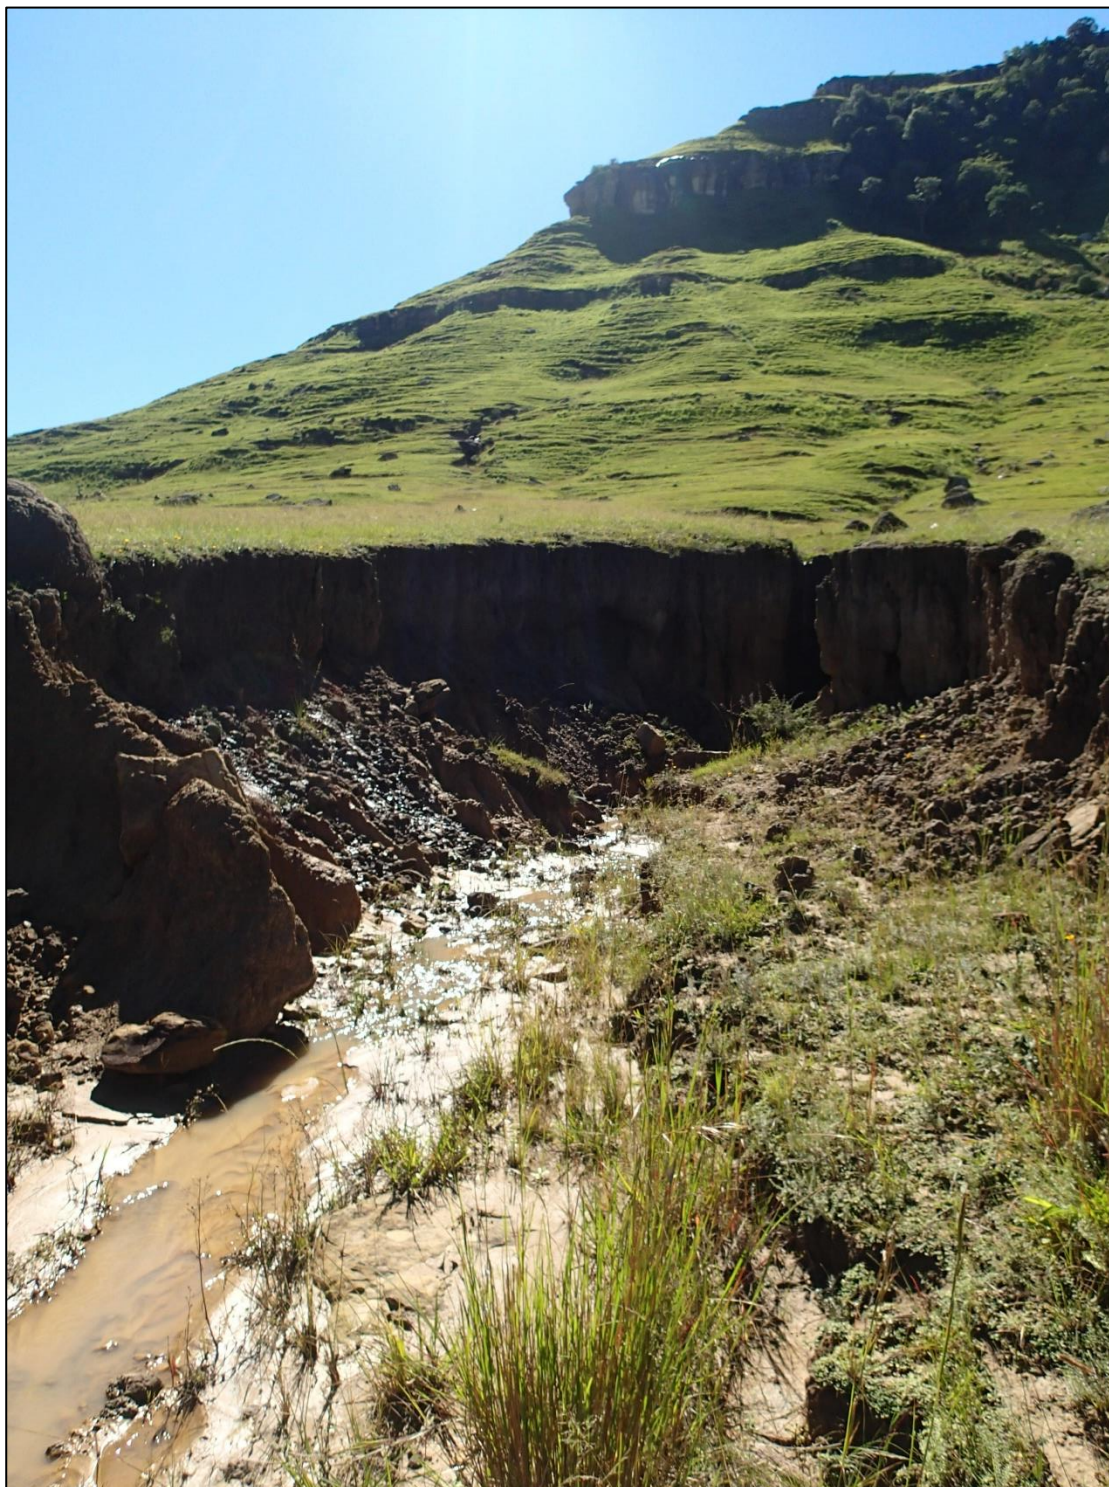
Figure 83 shows the extent of erosion in a similar hillslope seep where headward erosion has cut into the soft sediment deposits of the wetland seep due to a disturbance of the natural vegetation cover. This likely occurred due to over-utilisation and trampling of the wetland by livestock.

FIGURE 83: EROSION OF A HILLSLOPE SEEP RUNNING PARALLEL TO WETLAND 1 EXHIBITING A LOSS OF ECOSYSTEM SERVICES

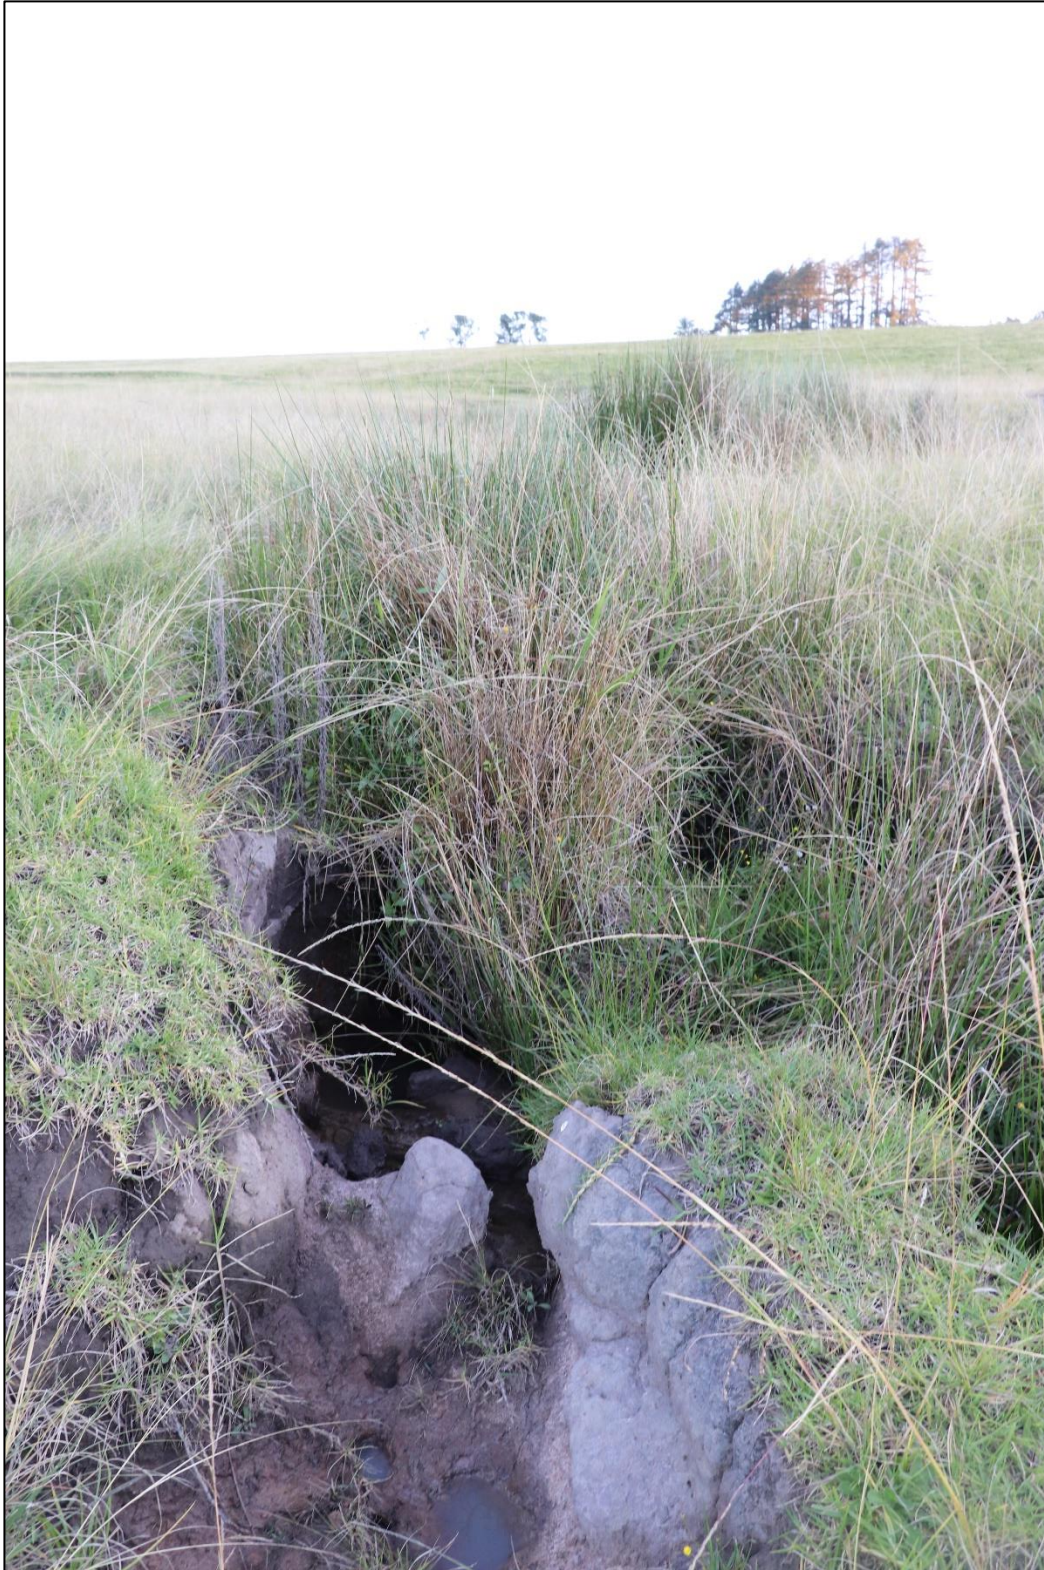
FIGURE 85: HEADWARD EROSION AT THE TOE OF WETLAND 2 DUE TO LIVESTOCK PRESSURES

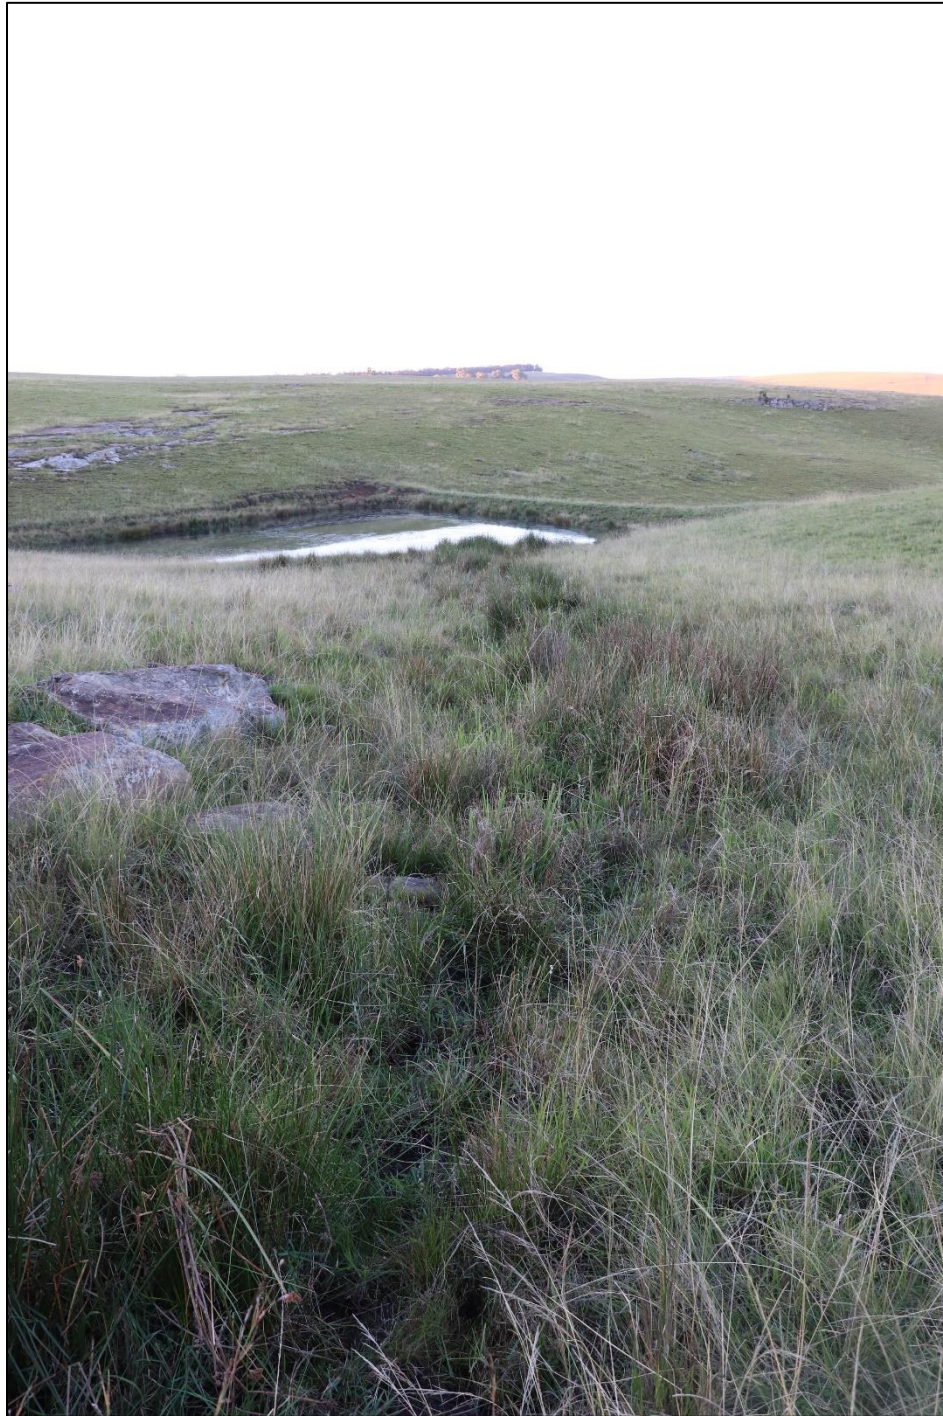
FIGURE 86: FIXED POINT PHOTOGRAPH OF WETLAND 2. PHOTOGRAPH TAKEN AT 15H15 ON THE 29/04/2019

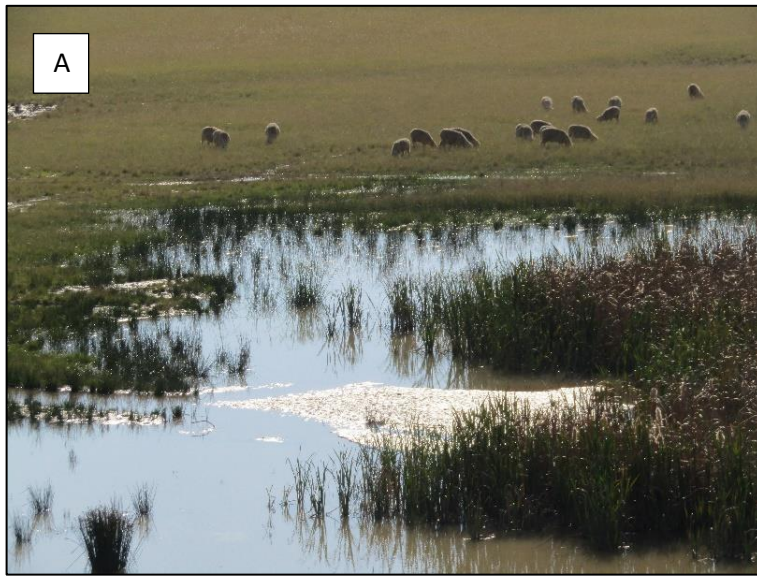
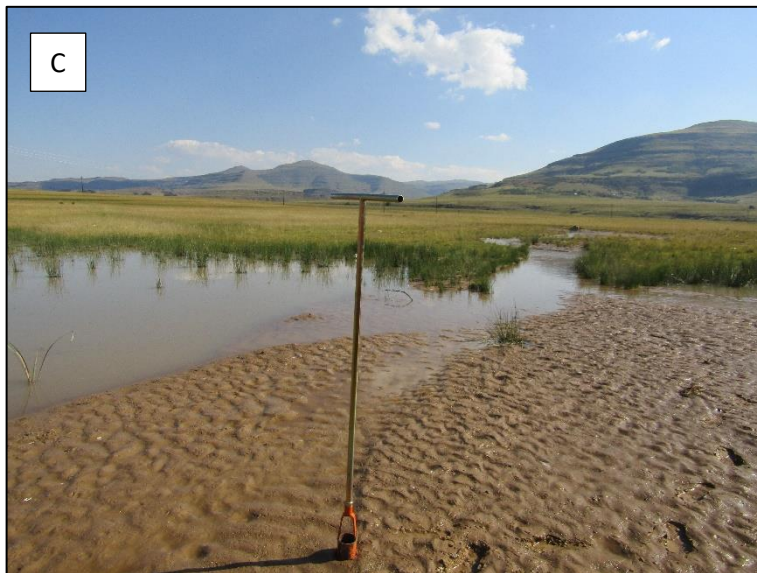
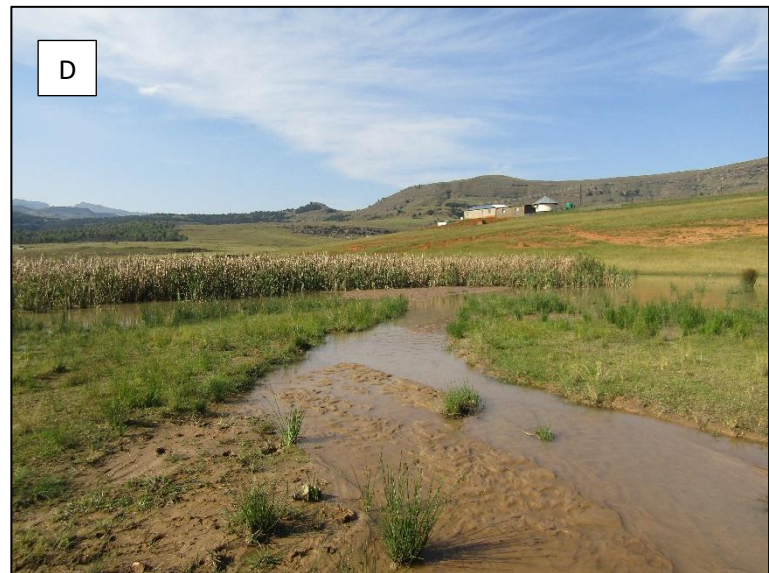
FIGURE 89: ECOSYSTEM SERVICES PROVIDED BY WETLAND 3. A: LIVESTOCK GRAZING AND DRINKING; B: PROVIDING HABITAT FOR BIRDS INCLUDING RED-KNOBBED COOTS AND WEAVER SPECIES; C & D: SEDIMENT AND NUTRIENT TRAPPING AS WELL AS CATCHING TOP SOIL BEFORE IT IS DEPOSITED IN THE RIVER SYSTEM

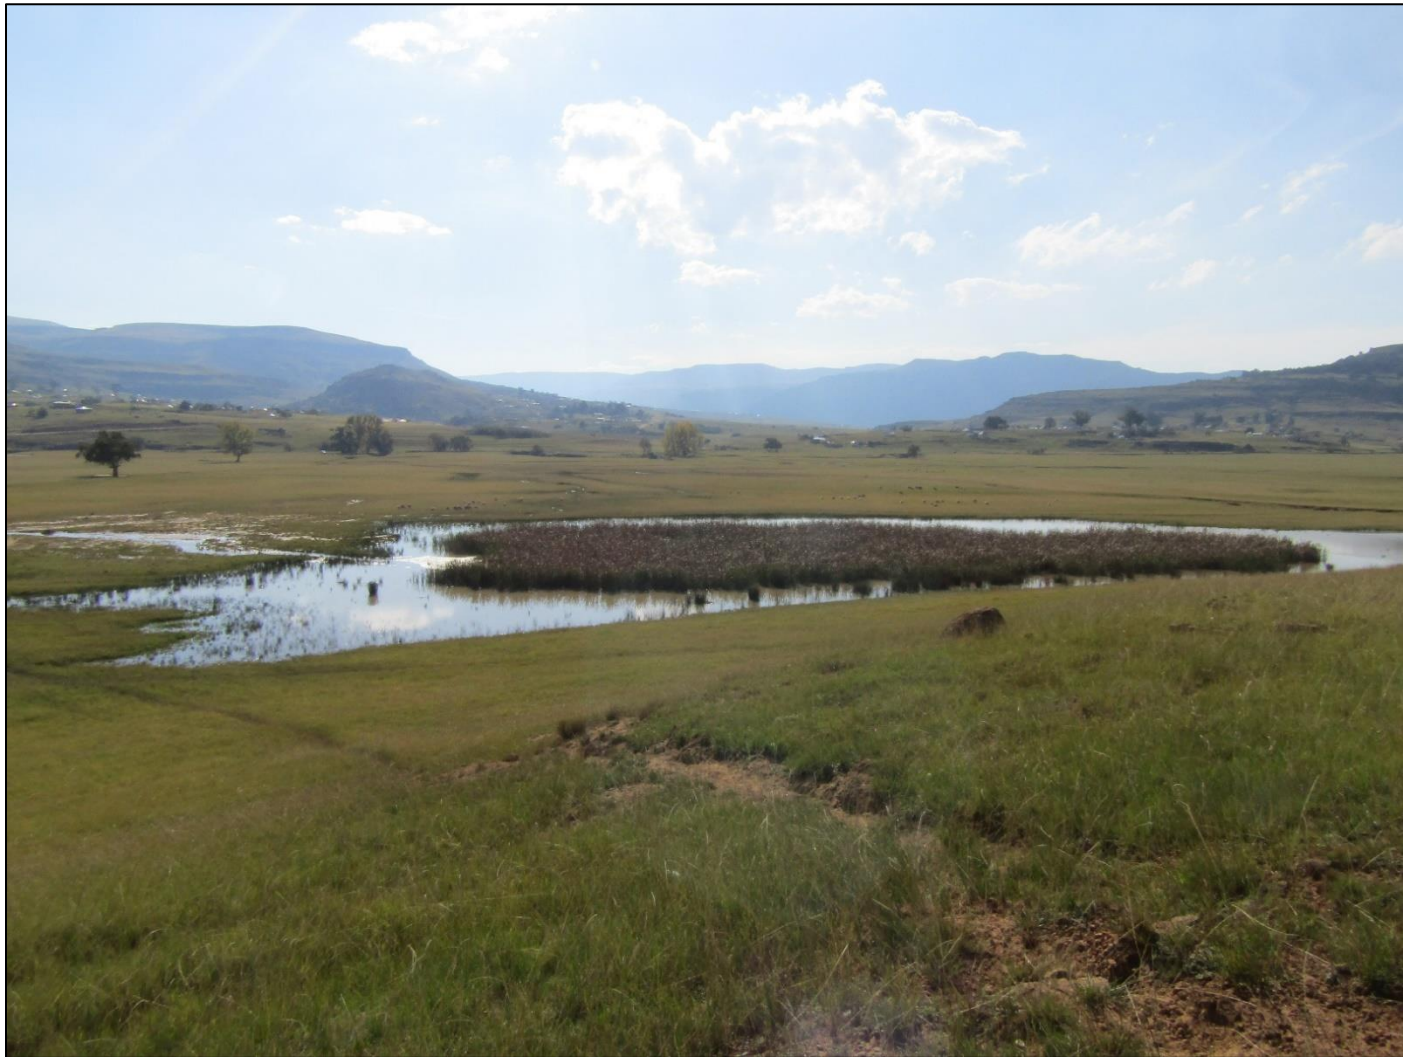
FIGURE 90: LANDSCAPE PHOTOGRAPH OF THE DEPRESSION WETLAND WITHIN THE WETLAND 3 SYSTEM. PHOTOGRAPH TAKEN AT 15H30 ON THE 01/05/2019

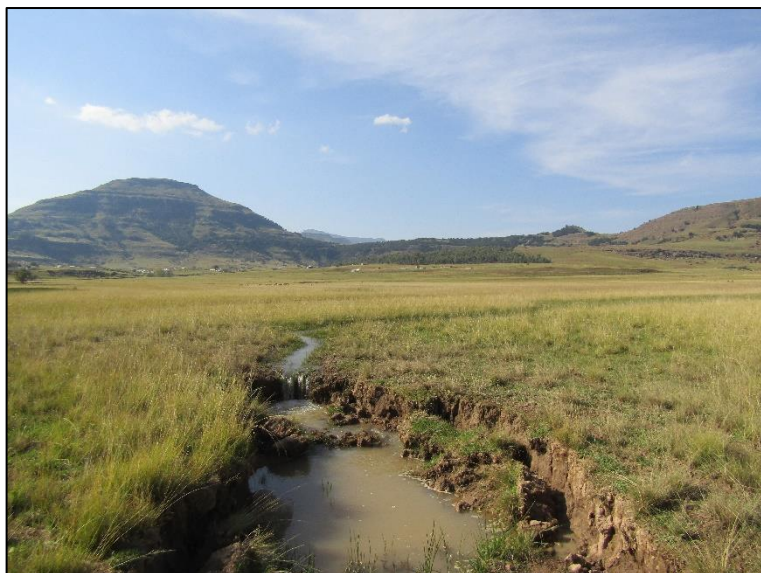
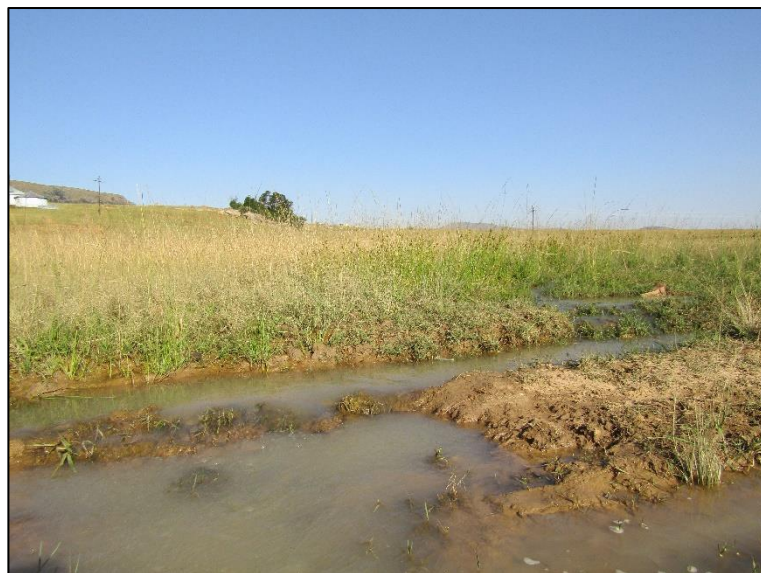
FIGURE 91: SIGNS OF DEGRADATION IN WETLAND 3

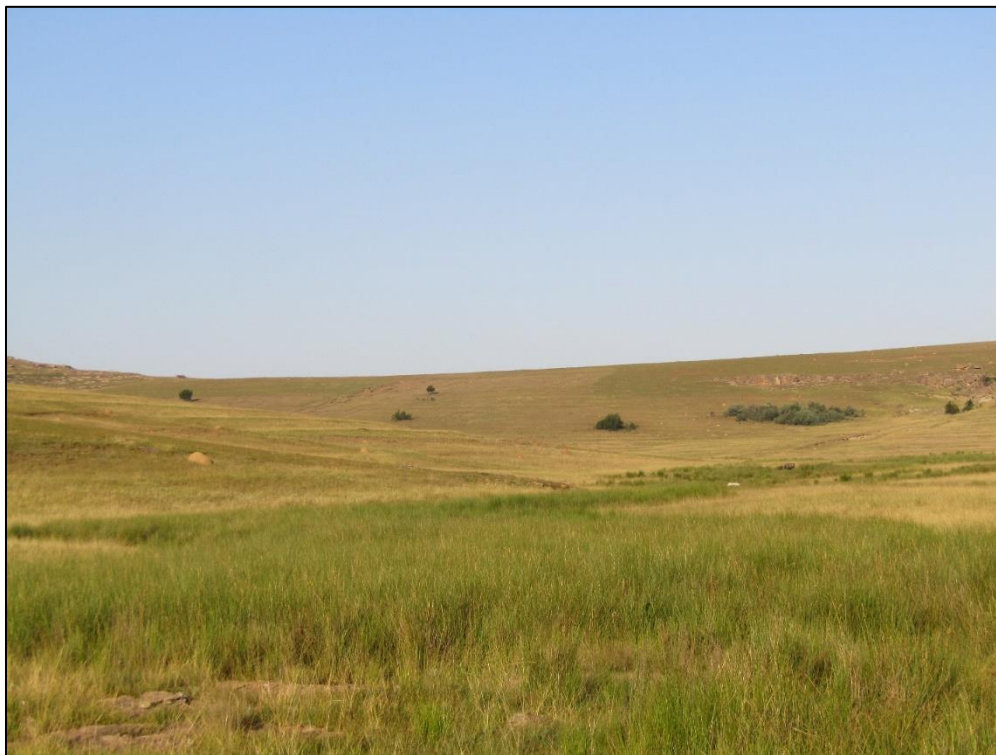
FIGURE 95: THE UN-CHANNELLED VALLEY BOTTOM WETLAND WITHIN THE **Wetland 4** SYSTEM. PHOTOGRAPH TAKEN AT 16H00 ON THE 01/05/2019

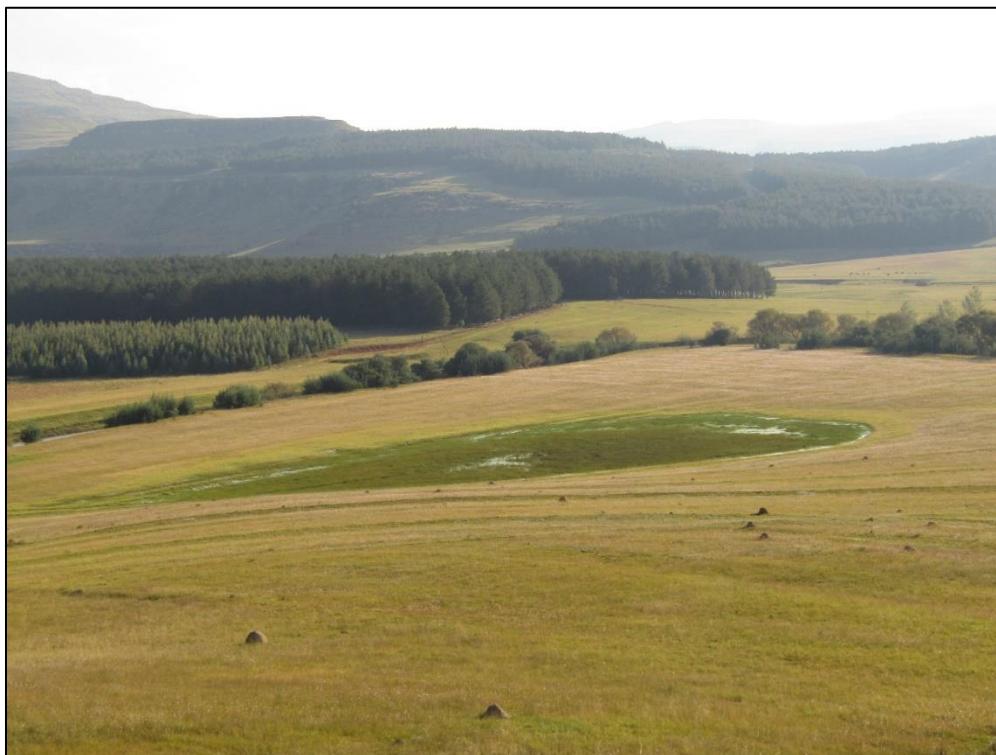
FIGURE 96: THE MIDDLE HILLSLOPE SEEP WETLAND WITHIN THE **Wetland 4** SYSTEM WHICH EXHIBITS A GOOD CONDITION.

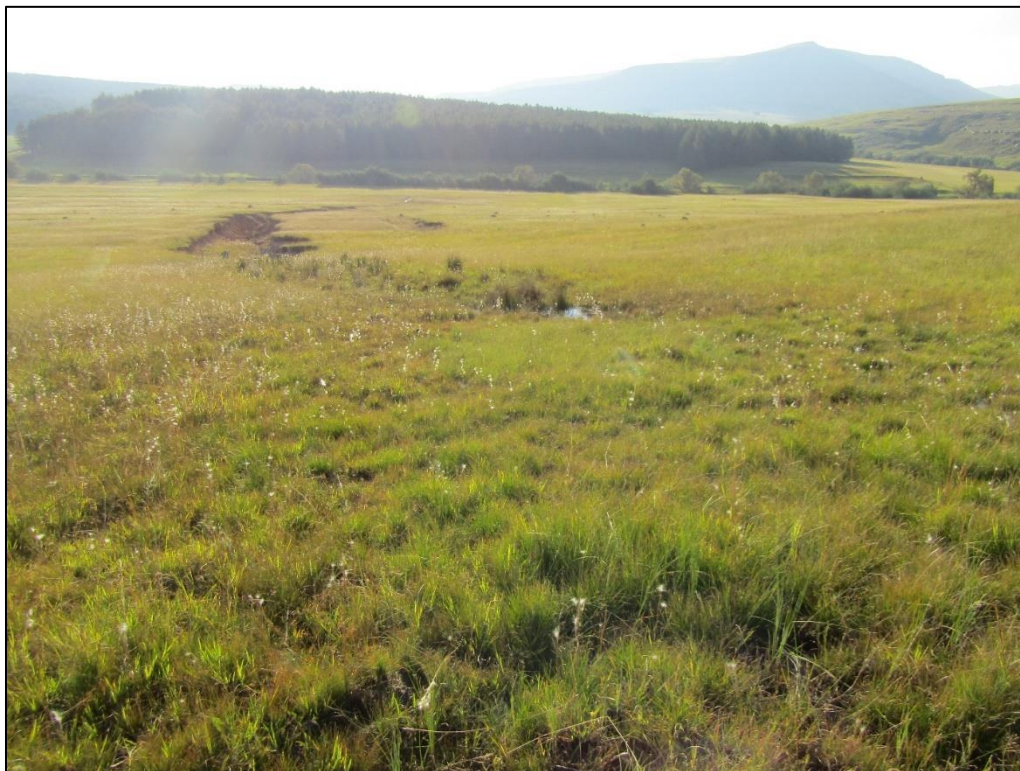
FIGURE 97: THE RIGHT MOST HILLSLOPE SEEP AND SPRING, WITHIN THE WETLAND 4 SYSTEM, EXHIBITING HEADWARD EROSION TOWARDS THE SPRING

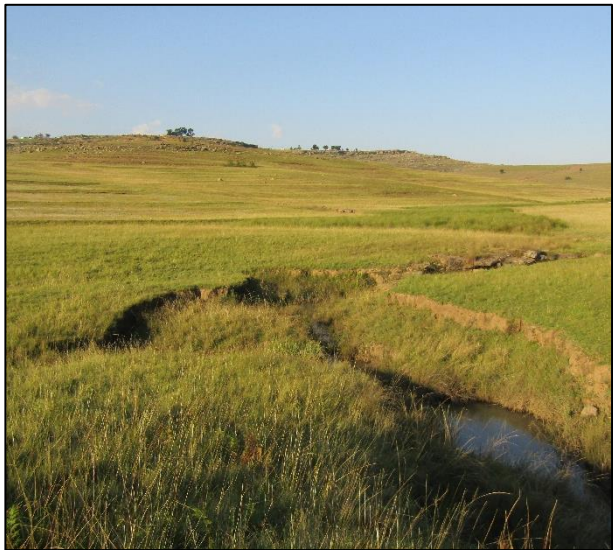
FIGURE 98: BEDROCK INTRUSION AT THE BASE OF THE WETLAND PROTECTING THE WETLAND FROM HEADWARD EROSION ORIGINATING FROM THE CONFLUENCE OF THE WETLAND CHANNEL WITH THE TSITSA RIVER

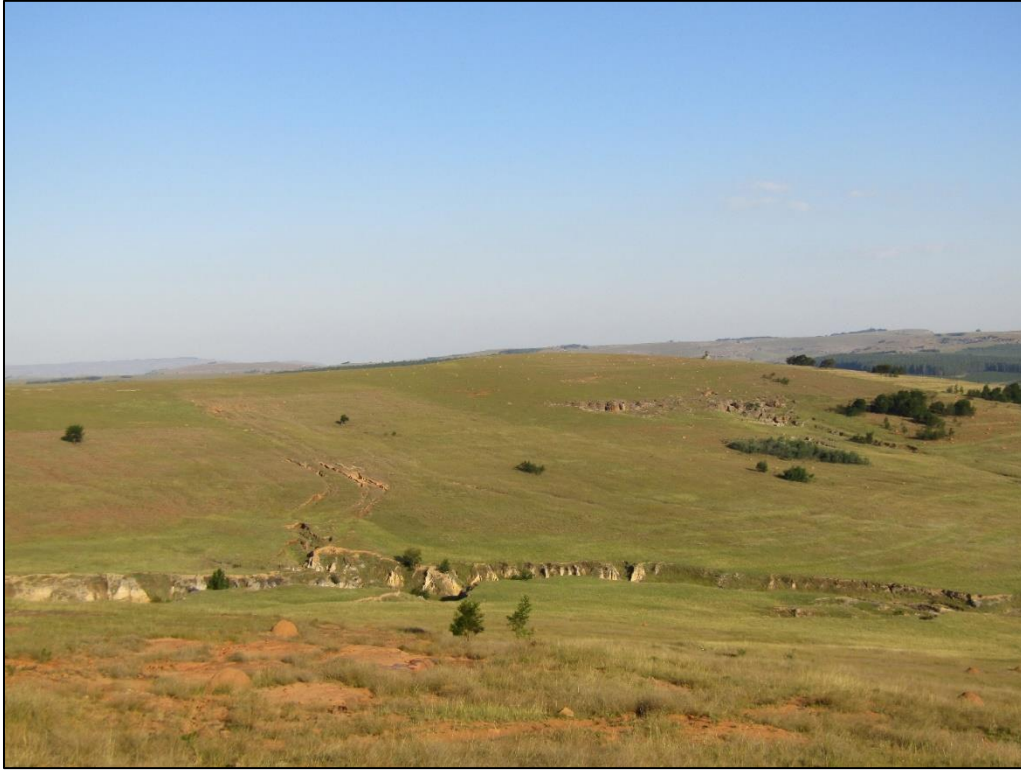
FIGURE 99: EROSION GULLIES AT THE HEAD OF THE WETLAND EXHIBITING STABLE SIDES

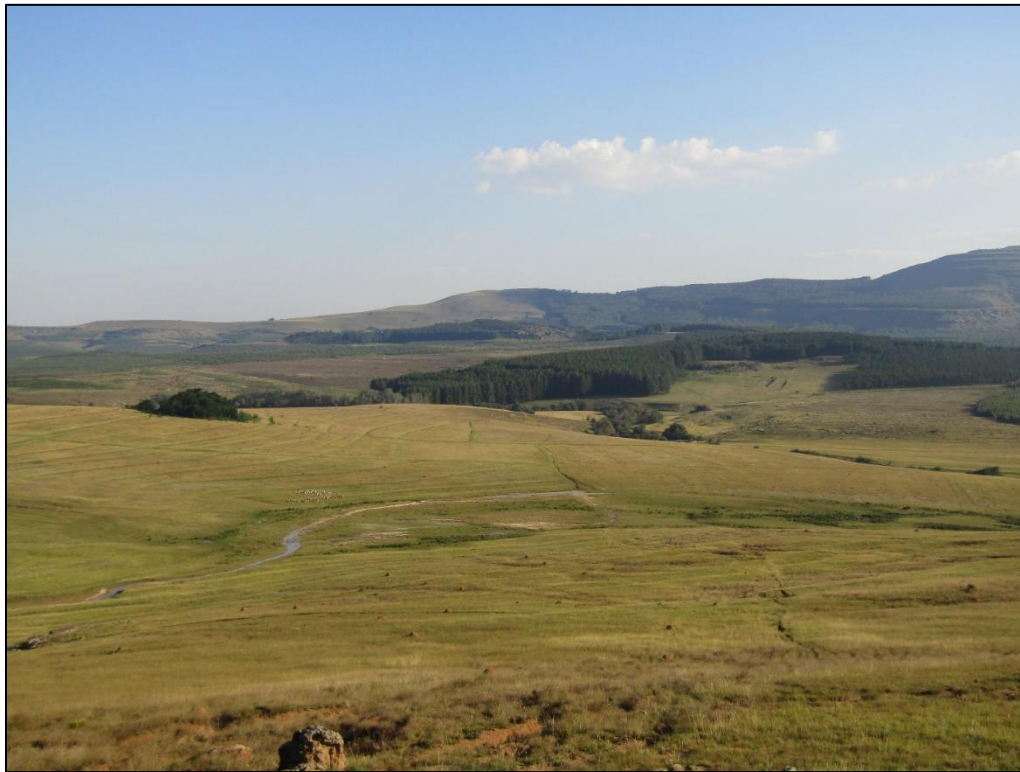
Wetland 4 consists of several wetlands in and adjacent to a natural drainage line off a steep slope onto the floodplains of the Tsitsa River (Figure 94). Wetland 4 consists of an un-channelled valley bottom wetland running down the drainage line (Figure 95) as well as two hillslope seeps coming off the steeper slopes (Figure 96 & Figure 97). The wetlands seep into the Tsitsa River. There are several springs providing water input into the wetlands. Water and sediment input is also provided by the surrounding hillslopes. A bedrock intrusion at the toe of the un-channelled valley bottom plays a part in the formation of the wetland above it (Figure 98). The intrusion also creates a resistant layer at the toe of the wetland which inhibits headward erosion from the Tsitsa River which is incised. Erosional gullies at the head of the un-channelled valley bottom wetland occur as the gradient increases (Figure 99). Sediment from these gullies is deposited further down in the wetland where the gradient decreases (Figure 100). Small-scale informal sand mining was observed in this area.

FIGURE 100: ALLUVIAL FAN AT THE FOOT OF THE SLOPE EXHIBITING GOOD VEGETATION GROWTH AND IT ALSO SHOWS SHEEP UTILIZING THE WETLAND FRINGES

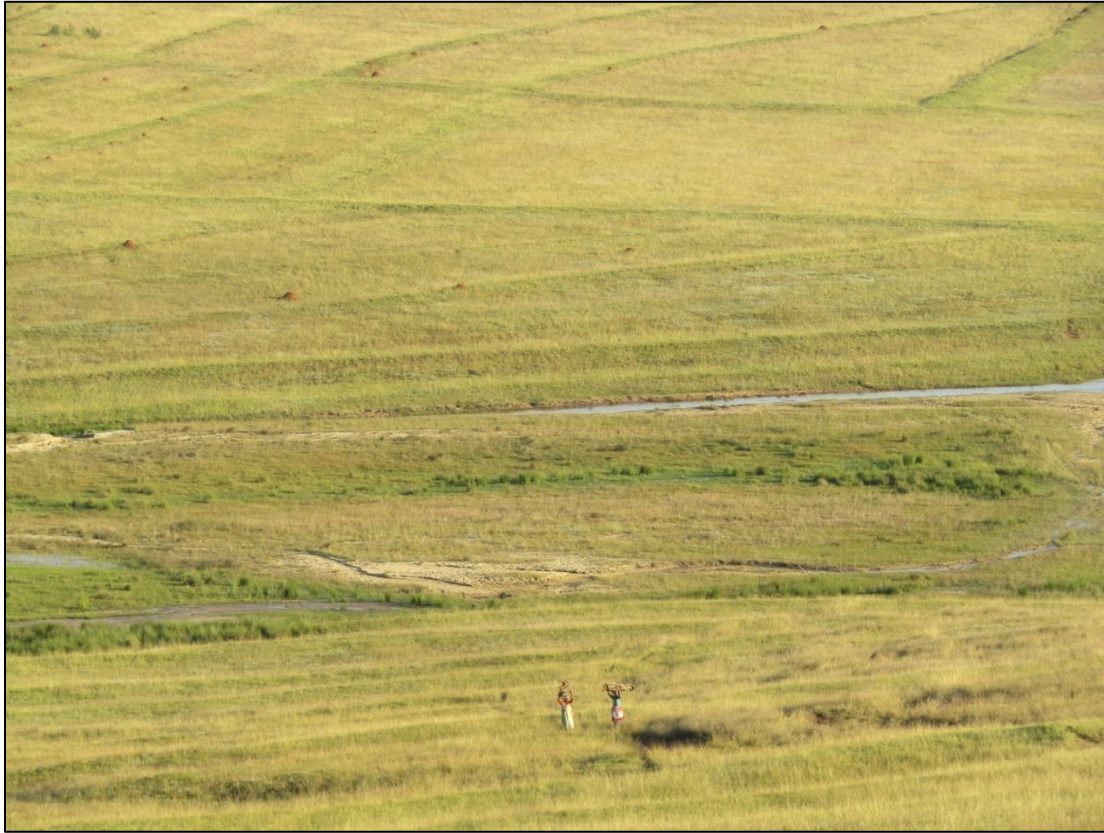
FIGURE 103: LOCAL VILLAGERS COLLECTING FIREWOOD IN THE VALLEY. SMALL-SCALE SAND MINING WAS ALSO OBSERVED IN THE ALLUVIAL FAN

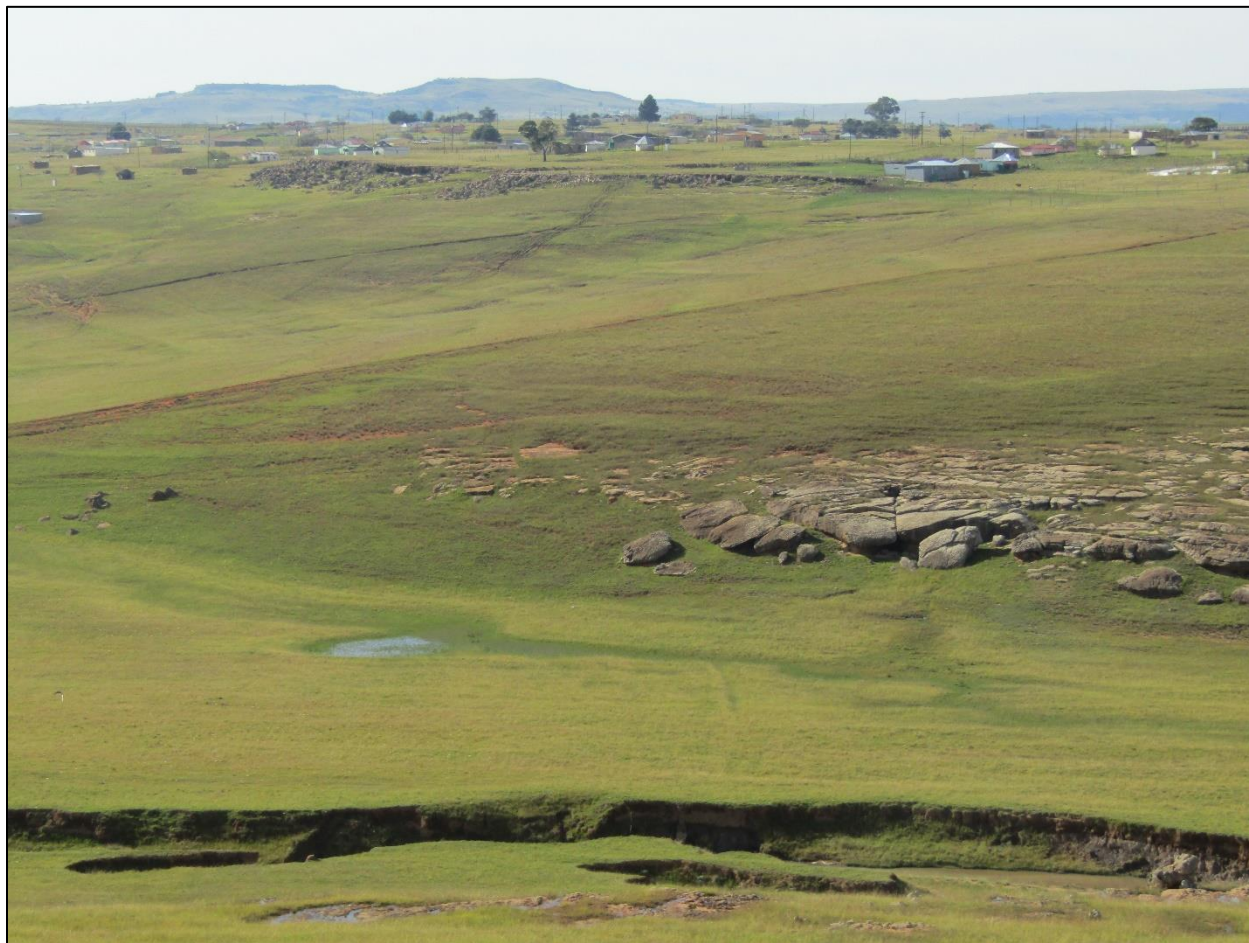
Wetland 5 is a Hillslope seep situated on a floodplain step of the Hlankomo River (Figure 105 and Figure 106). It is used by livestock for grazing and traps sediment from the surrounding landscape reducing sediment transport into the Hlankomo River. Wetland 5 is representative of several such wetlands found along the banks of the smaller rivers where they have a narrow valley surrounded by steeper slopes.

FIGURE 106: WETLAND 5 IS A HILLSLOPE SEEP WETLAND ON THE BANKS OF THE HLANKOMO RIVER. PHOTO TAKEN AT 09H45 ON THE 02/05/2019

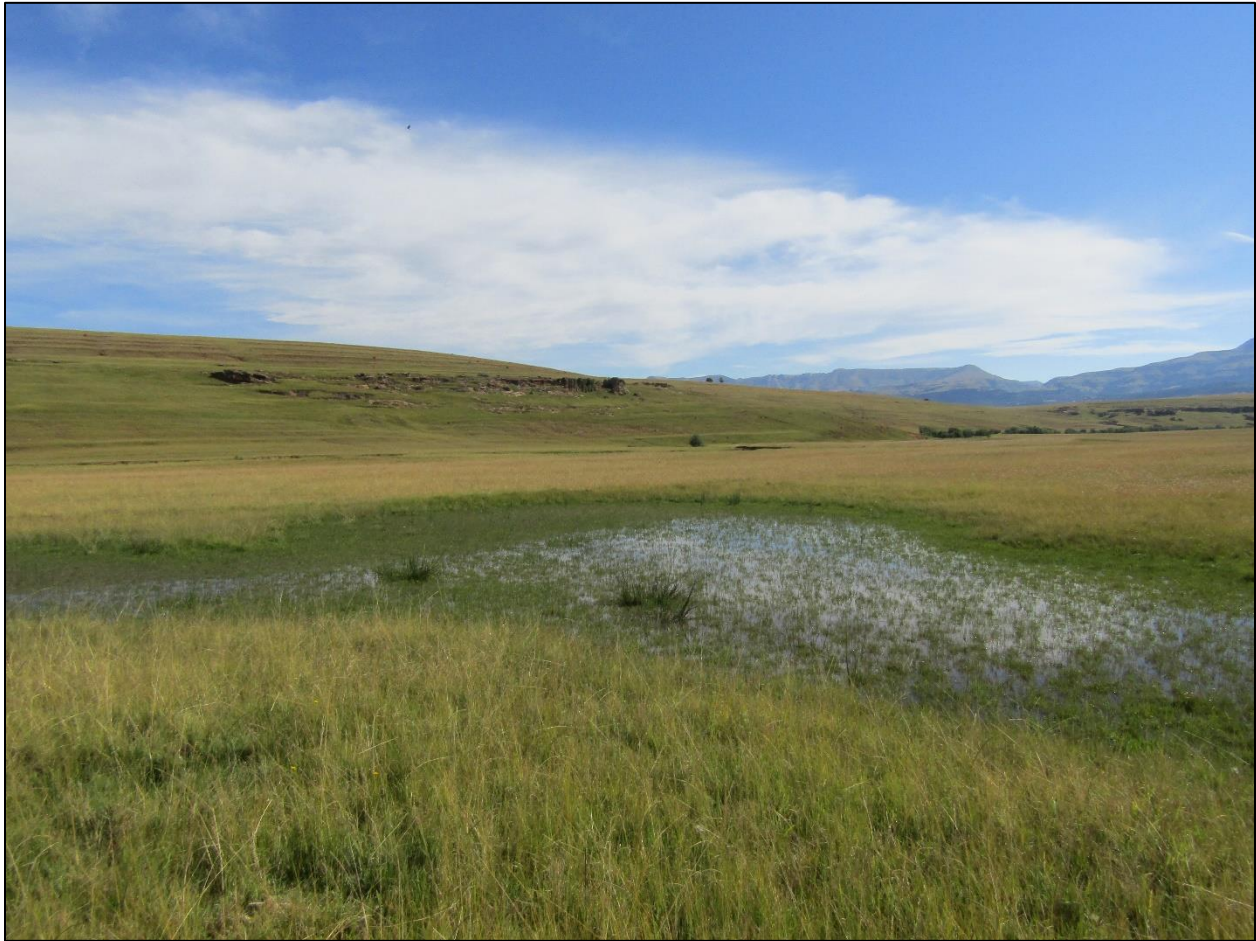
FIGURE 107: PERMANENT WATER AND MARSHY AREA IN WETLAND 5
