BIOPHYSICAL MONITORING: REPORT 1 OF THE UPPER TSITSA RIVER CATCHMENT (T35 A-E)

TSITSA PROJECT

Huchzermeyer, N; Schlegel, P; van der Waal, B

August 2019

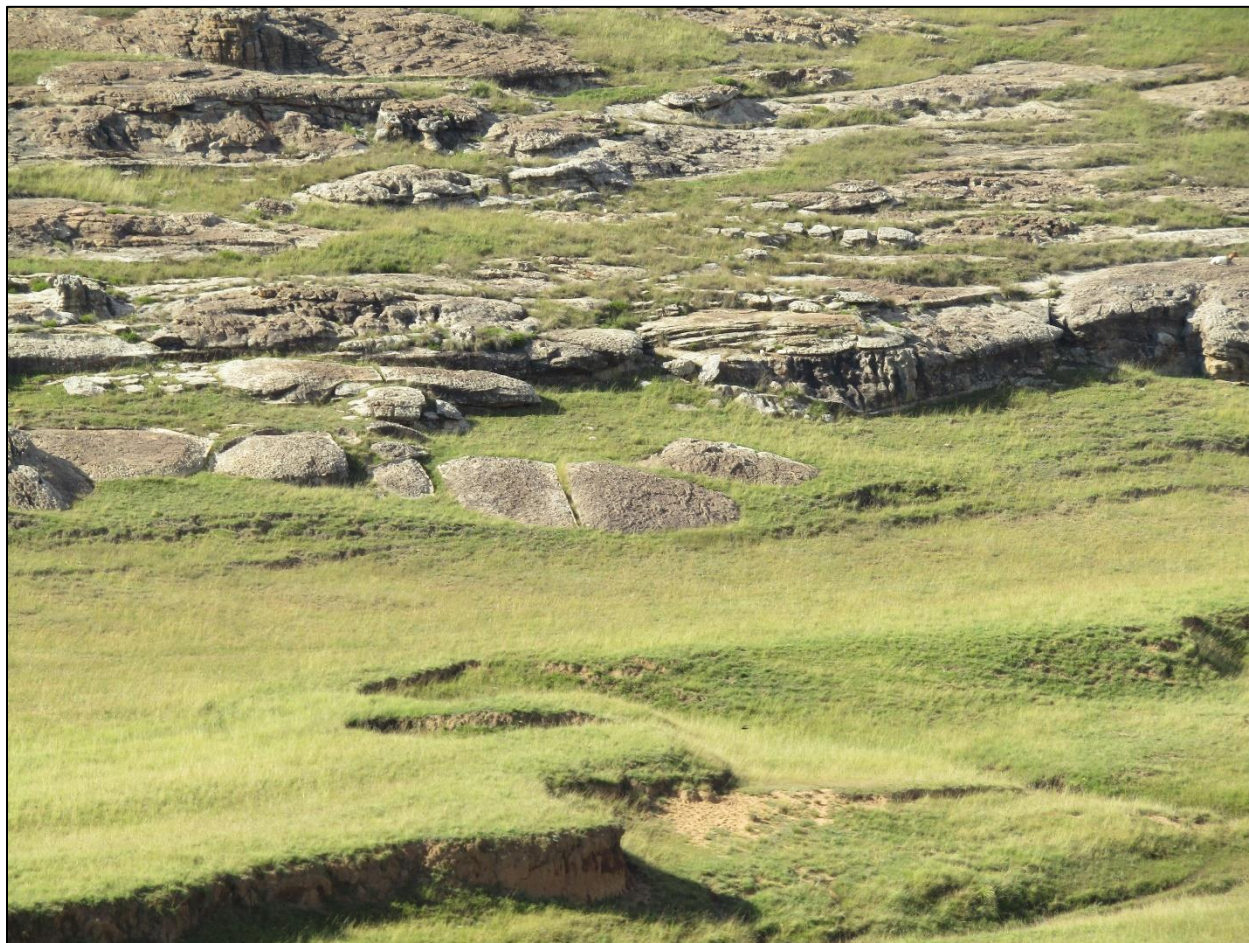
FIGURE 109: STABLE EROSIONAL NICK POINTS AT THE TOE OF WETLAND 5

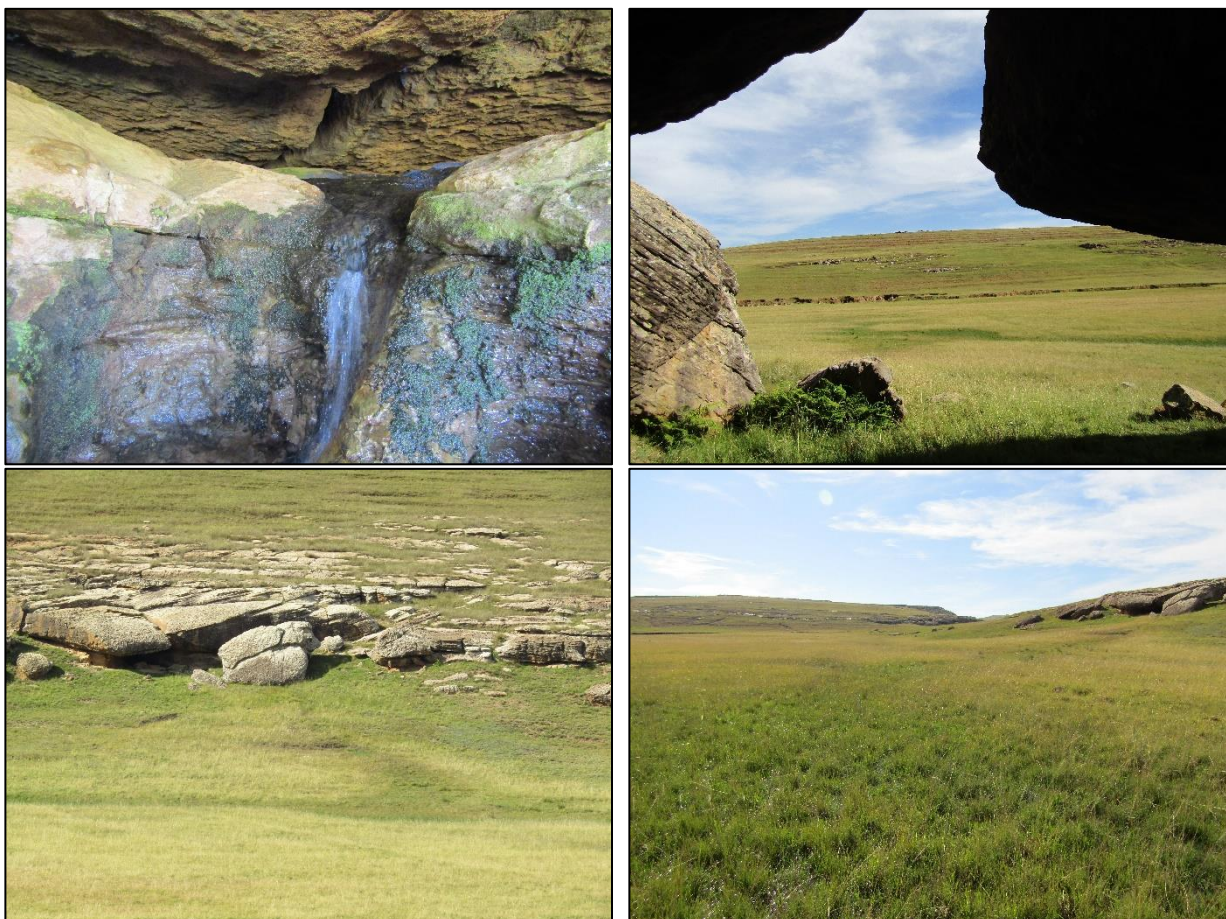
Wetland 5 has a small catchment on the hillslope above it. Sediment and run-off from the hillslope above is diverted by a prominent livestock path that leads to a river crossing and continues to grazing lands on the adjacent slopes. Erosion is likely to occur here as water is concentrated leading to an increase in sediment transport straight into the Hlankomo river. Erosional nickpoints at the toe of the wetland (Figure 109) are stable but could become active due to riparian and bank disturbances. Wetland 5 receives water from a spring coming out of the rocks at the edge of the mountain (Figure 110).

FIGURE 110: IN WETLAND 5 THE WATER REACHES THE SURFACE BETWEEN A ROCK OUTCROP AND SEEPS ONTO THE LOW GRADIENT FLOODPLAIN BELOW

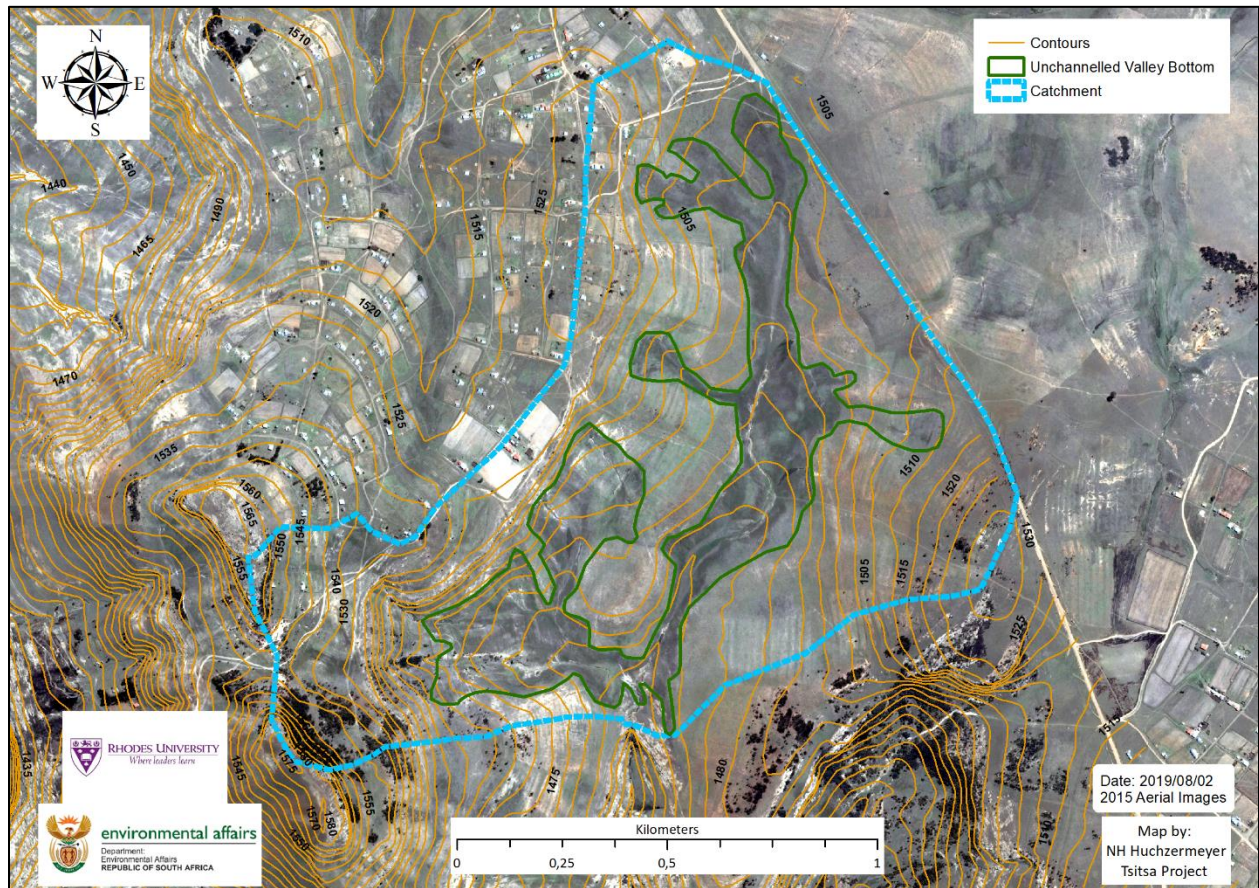
Wetland 6 has a catchment area of 161 ha which includes a main district road and a village with cultivated lands that contribute sediment into the wetland system (Figure 112). The local village could benefit from proper management of the springs which can include, a pond to catch water, easier access, dedicated livestock drinking area etc.

FIGURE 112: CATCHMENT AREA ABOVE WETLAND 6

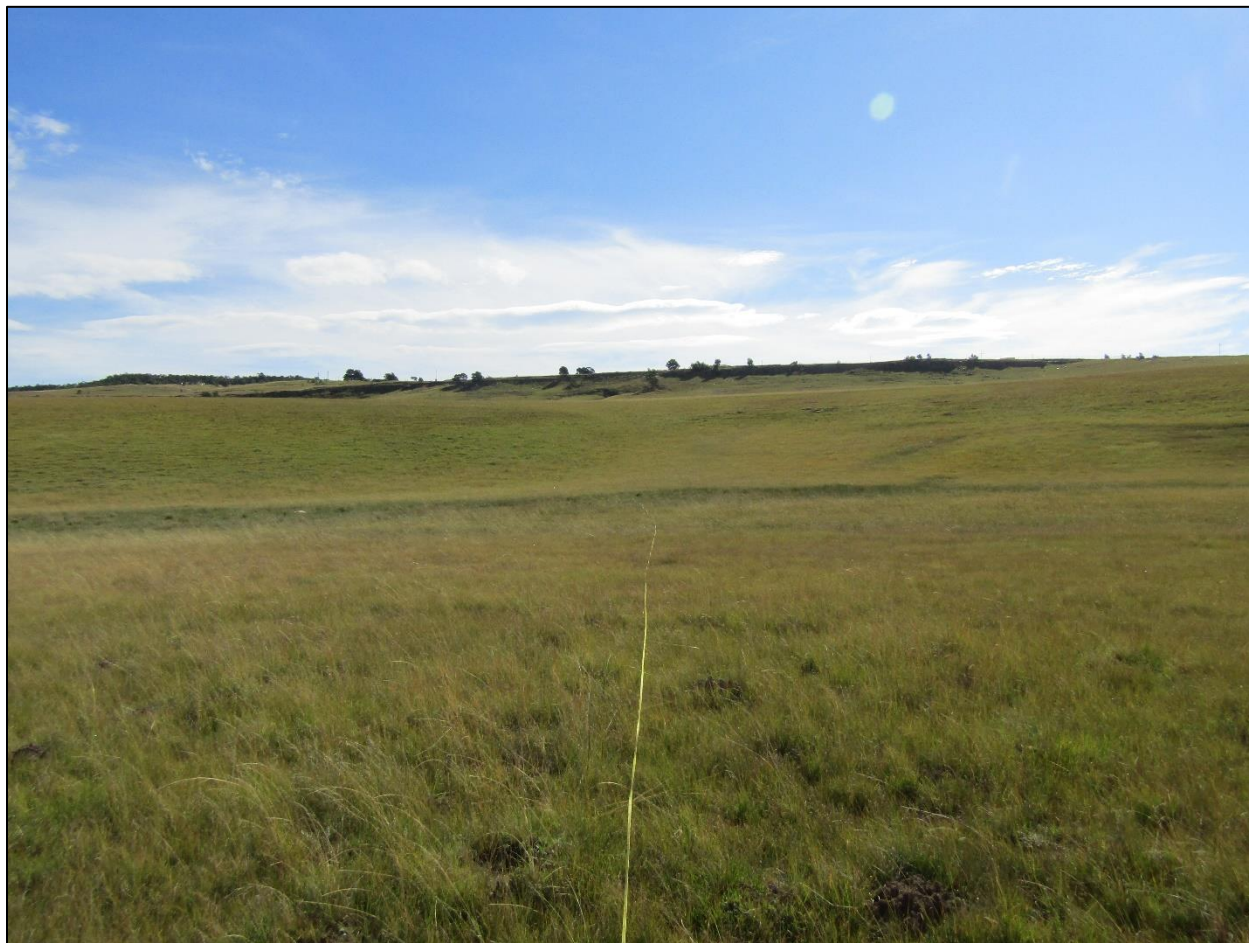
FIGURE 113: CROSS-SECTIONAL VIEW ACROSS THE MIDDLE OF THE UN-CANNELLED VALLEY BOTTOM WETLAND (WETLAND 6)

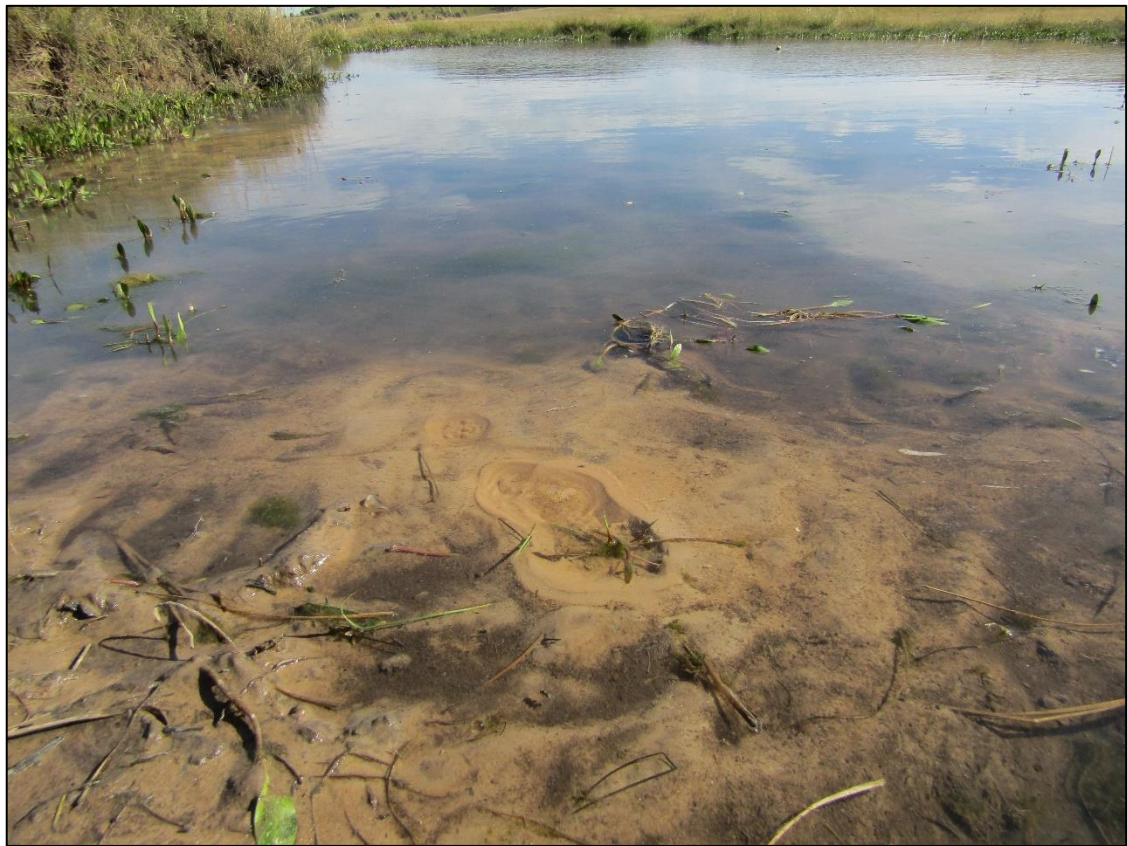
Wetland 6 is a large (43 ha) un-channelled valley bottom wetland (Figure 111). Wetland 6 is used by livestock grazing and has several springs (Figure 114) that are used by the local villagers for water collection and by livestock for drinking. Wetland 6 catches sediment from the surrounding landscape. There is headward erosion present in the wetland but it is situated on the higher slopes. Erosion around the springs should be monitored. Wetland 6 is controlled by bedrock at the toe of the wetland protecting it from headward erosion at the toe.

FIGURE 114: SPRING AT THE TOP OF WETLAND 6

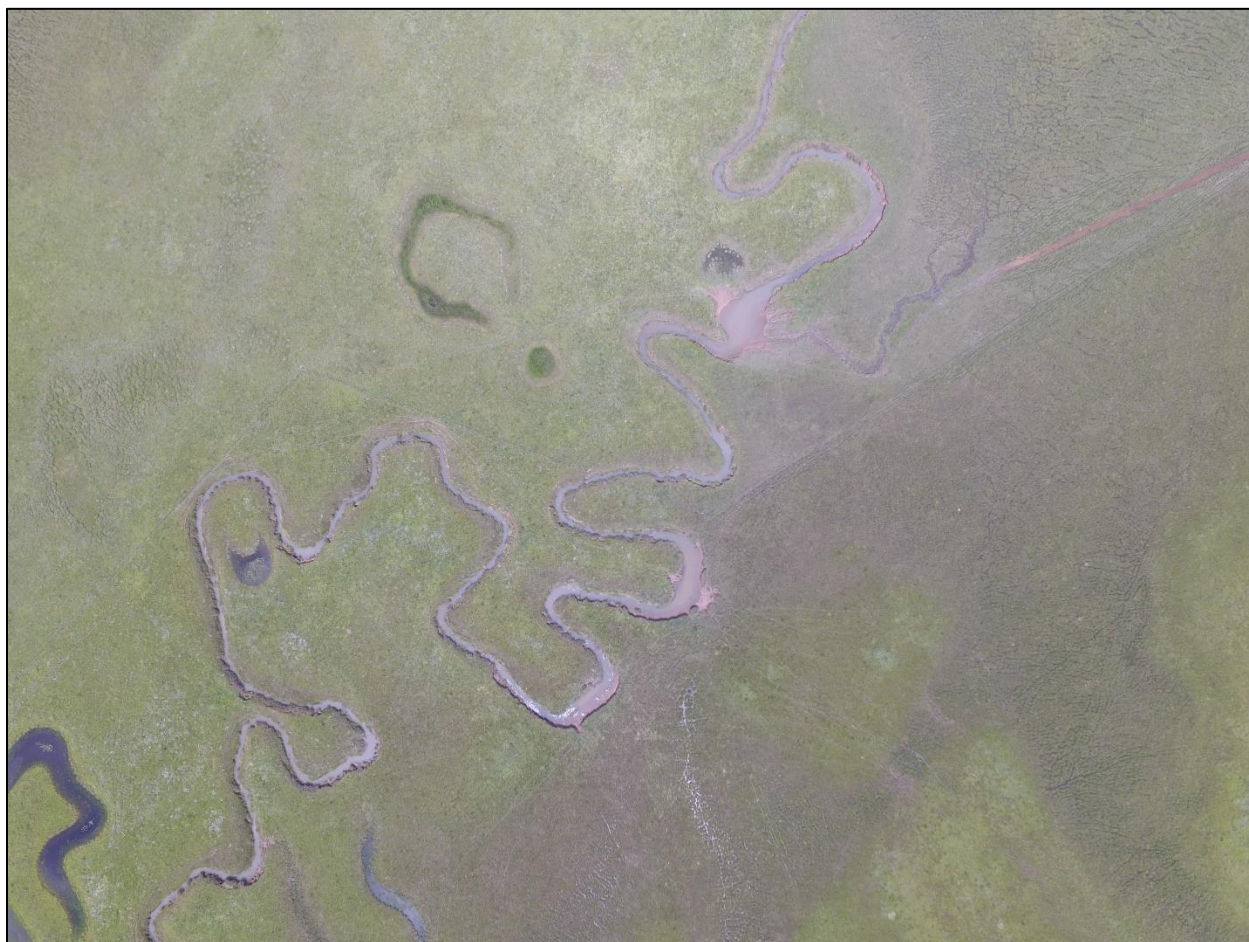
FIGURE 118: MEANDER BENDS PRESENT IN THE FLOODPLAIN WETLAND

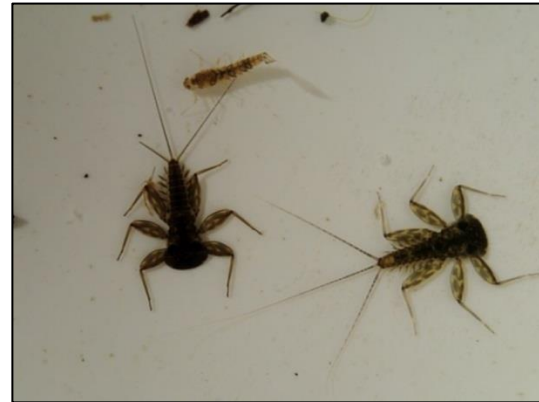
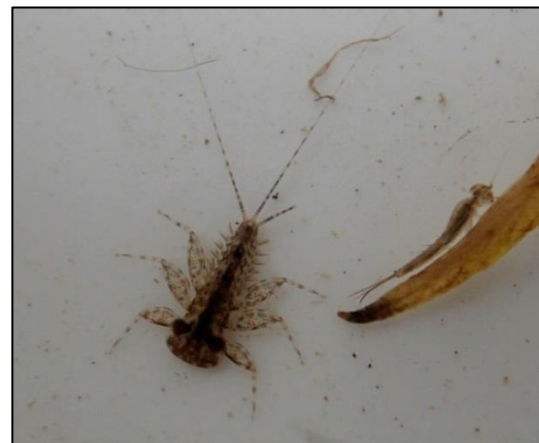
- Were found in habitats with a high sediment concentration, however their abundance was higher the lower the concentration of fine sediment drape.

Macroinvertebrate abundance	Surface sediment drape (g/m ²) in habitat		Sensitivity score

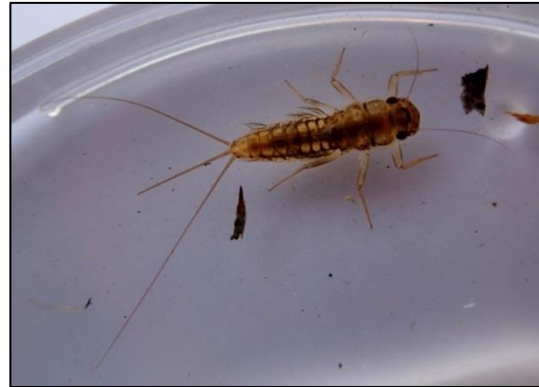
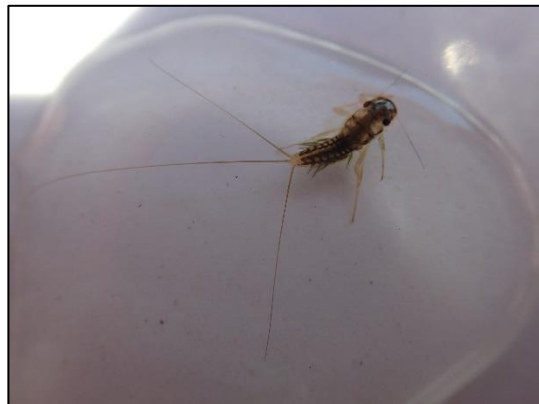
- Found in relatively high abundance in low to high concentrations of sediment drape; however abundance decreases with an increase in the concentration of fine sediment drape.

Macroinvertebrate abundance	Surface sediment drape (g/m ²) in habitat		Sensitivity score

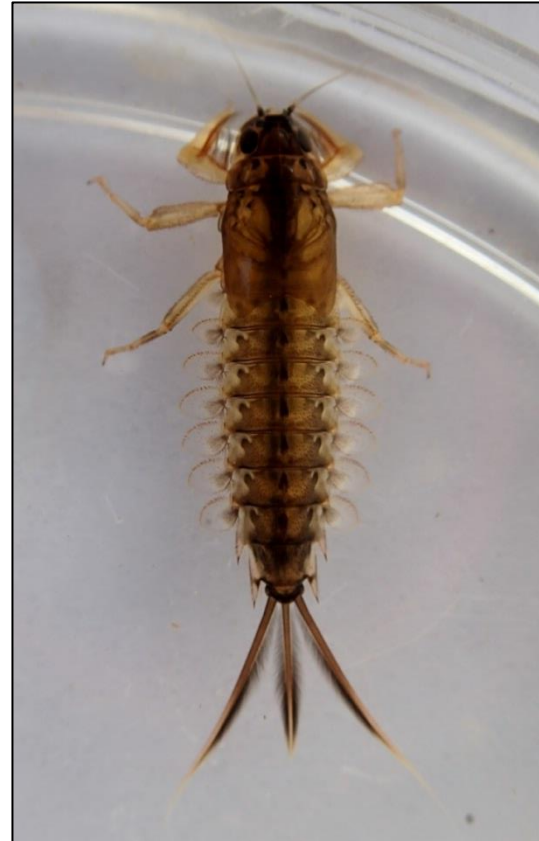
- Found in summer in patches of gravel in fast flowing areas of the river.
- Oligoneuridae were not found in habitats with a high concentration of fine sediment drupe.

Macroinvertebrate abundance	Surface sediment drupe (g/m ²) in habitat		Sensitivity score

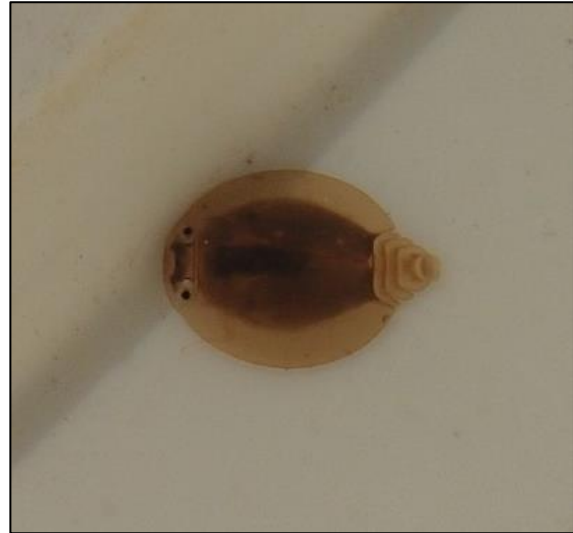
- Found in habitats with a low to medium concentration of fine sediment drape.

Macroinvertebrate abundance	Surface sediment drape (g/m ²) in habitat		Sensitivity score

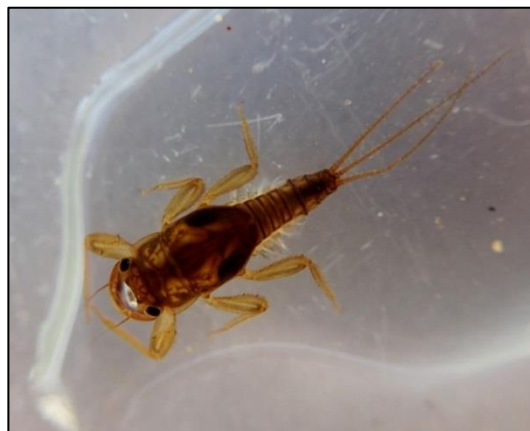
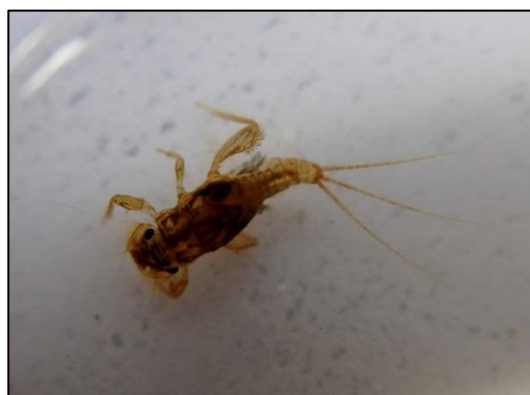
- Found in habitats with a low to high concentration of fine sediment drape, with abundance decreasing with an increase in sediment concentration.

Macroinvertebrate abundance	Surface sediment drape (g/m ²) in habitat		Sensitivity score

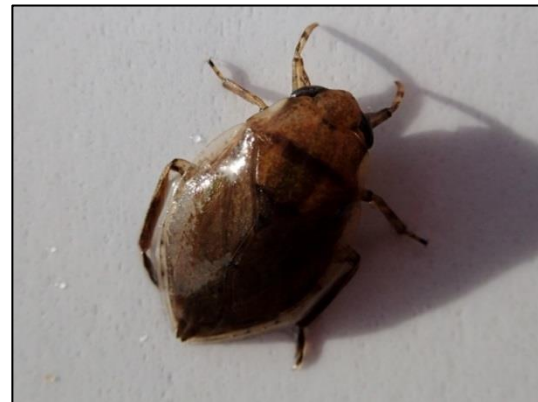
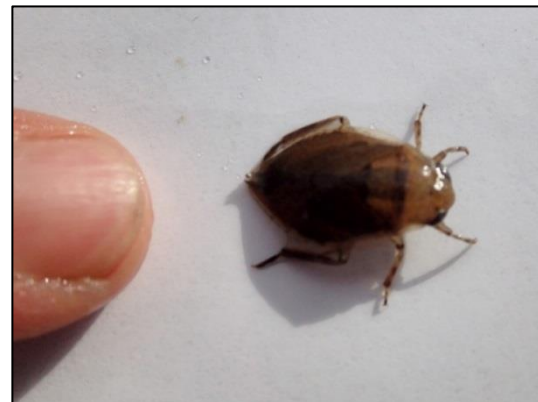
- Found in low abundance in low to medium concentrations of fine sediment.

Macroinvertebrate abundance	Surface sediment drupe (g/m ²) in habitat		Sensitivity score

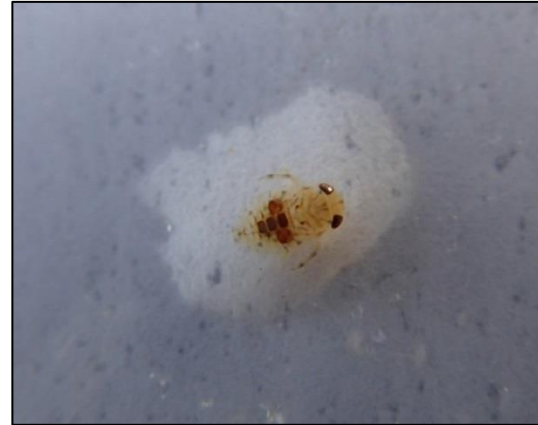
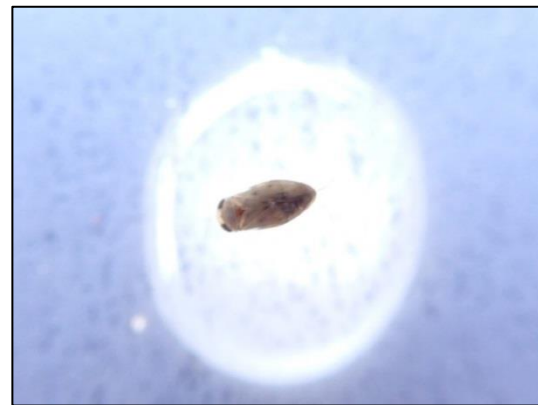
- Low to high concentrations of fine sediment with the highest abundance found in habitats with a high sediment concentration.

Macroinvertebrate abundance	Surface sediment drupe (g/m ²) in habitat		Sensitivity score

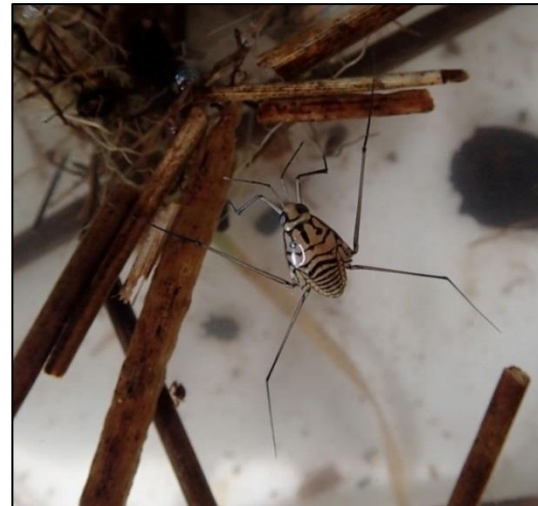
- Low abundance in habitats with low concentrations of fine sediment

Macroinvertebrate abundance	Surface sediment drupe (g/m ²) in habitat		Sensitivity score
↓	High	>10 000.1	1
		8 000.1 – 10 000.0	2
		4 000.1 – 8 000.0	3
		2 000.1 – 4 000.0	4
		1 000.1 – 2 000.0	5
	Moderate	800.1 – 1 000.0	6
		400.1 – 800.1	7
		200.1 – 400.0	8
		100.1 – 200.0	9
	Low	<100	10

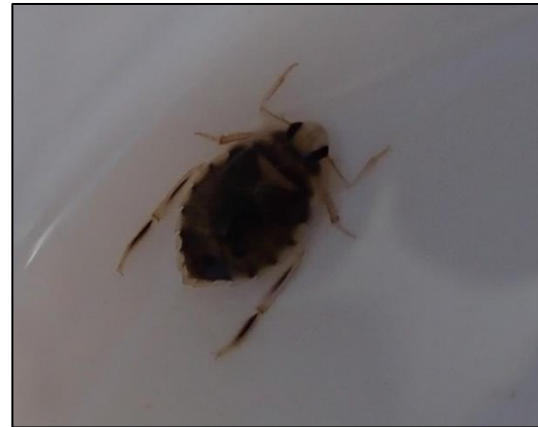
- Found in low to high concentrations of fine sediment with an increase in abundance with an increase in sediment concentration.

Macroinvertebrate abundance	Surface sediment drupe (g/m ²) in habitat		Sensitivity score

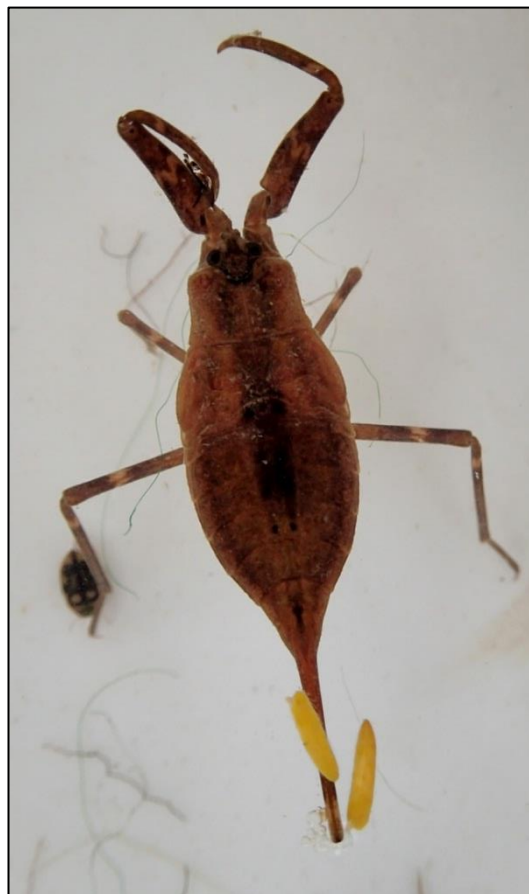
- Found in low abundance in habitats with low to medium concentrations of fine sediment.

Macroinvertebrate abundance	Surface sediment drupe (g/m ²) in habitat		Sensitivity score

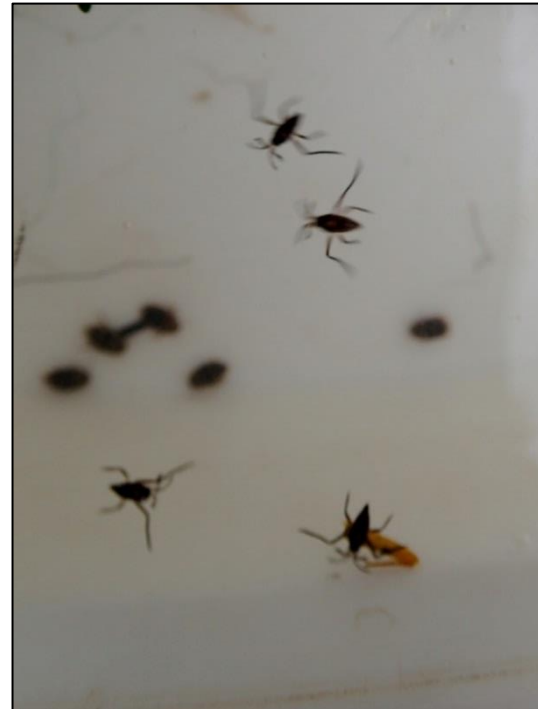
- Found in habitats with low to high concentrations of fine sediment and their abundance was not affected by an increase in sediment concentration

Macroinvertebrate abundance	Surface sediment drupe (g/m ²) in habitat		Sensitivity score

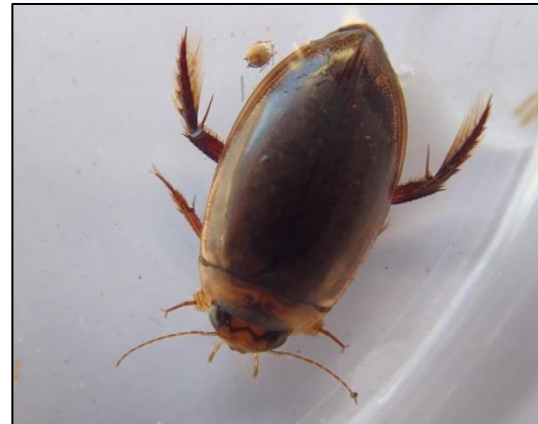
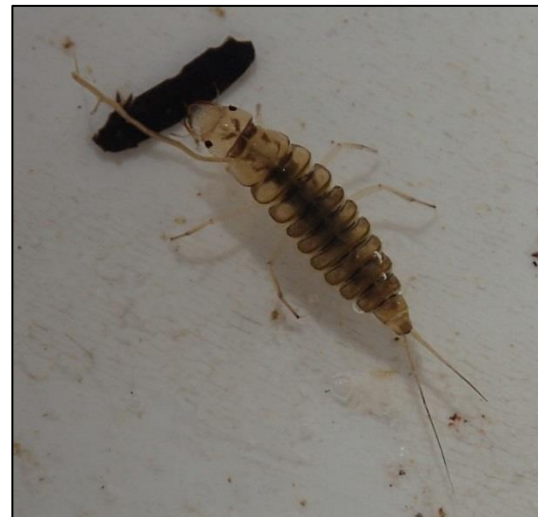
- Found in vegetation habitats with low to high concentrations of sediment with an increase in abundance with an increase in the concentration of surface sediment drupe.

Macroinvertebrate abundance	Surface sediment drupe (g/m ²) in habitat		Sensitivity score

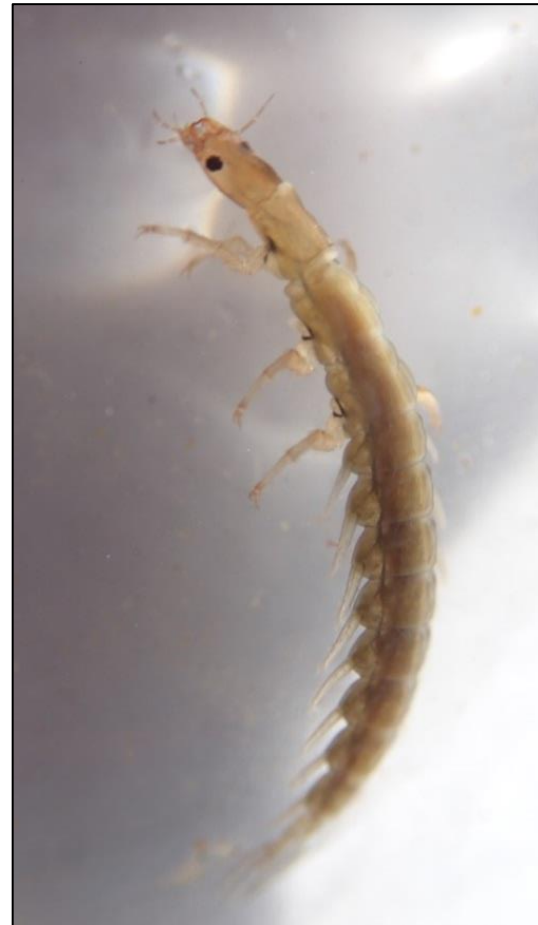
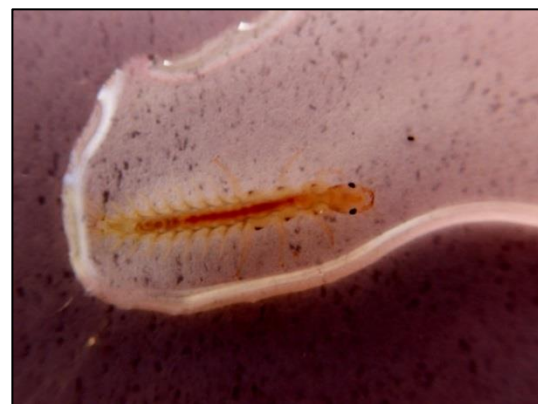
- Found in habitats with low to high concentrations of sediment with a low abundance in habitats with a high sediment concentration.

Macroinvertebrate abundance	Surface sediment drupe (g/m ²) in habitat		Sensitivity score

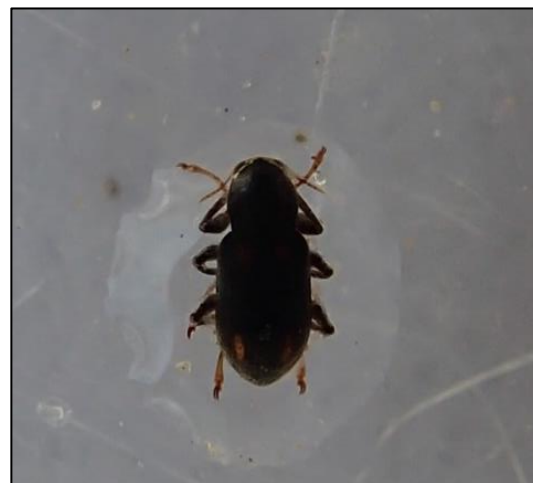
- Found in medium to low concentrations of sediment with abundance increasing with lower sediment concentrations

Macroinvertebrate abundance	Surface sediment drupe (g/m ²) in habitat		Sensitivity score

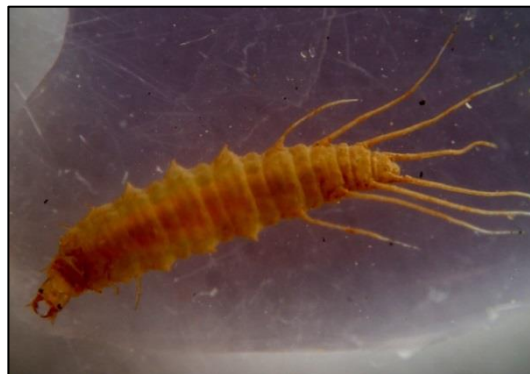
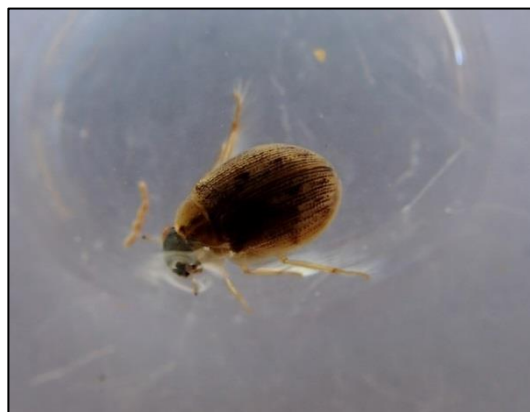
- Found in similar abundance in low to high concentrations of fine sediment.

Macroinvertebrate abundance	Surface sediment drupe (g/m ²) in habitat		Sensitivity score

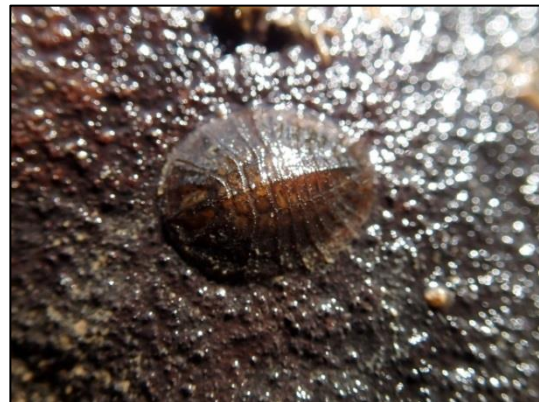
- Found in habitats with low to medium concentrations of fine sediment drape.

Macroinvertebrate abundance	Surface sediment drape (g/m ²) in habitat		Sensitivity score

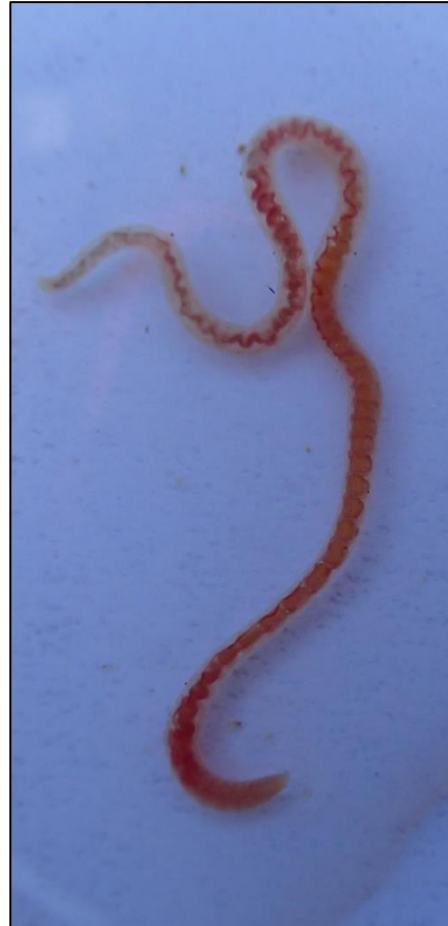
- Found in sandy and muddy habitats with low to high concentrations of fine sediment concentration with an increase in abundance with an increase in sediment concentration.

Macroinvertebrate abundance	Surface sediment drupe (g/m ²) in habitat		Sensitivity score

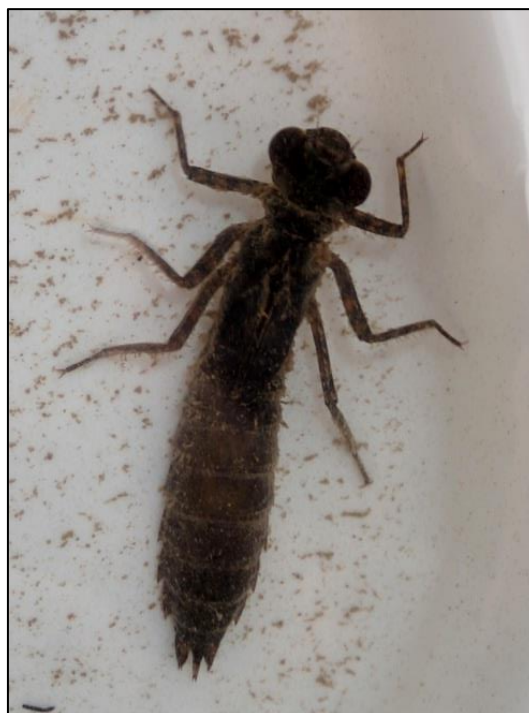
- Found in low to high concentrations of fine sediment

Macroinvertebrate abundance	Surface sediment drupe (g/m ²) in habitat		Sensitivity score

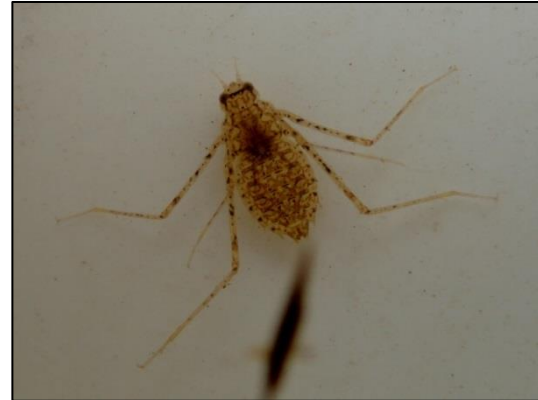
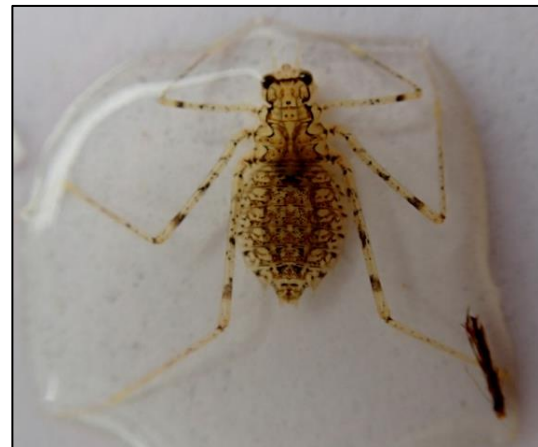
- Found in a low abundance in low to high concentrations of fine sediment

Macroinvertebrate abundance	Surface sediment drupe (g/m ²) in habitat		Sensitivity score

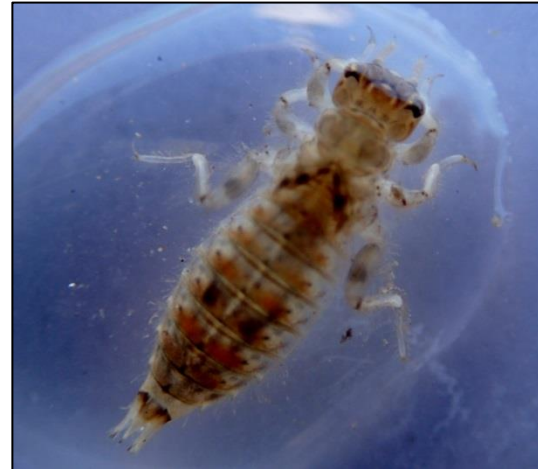
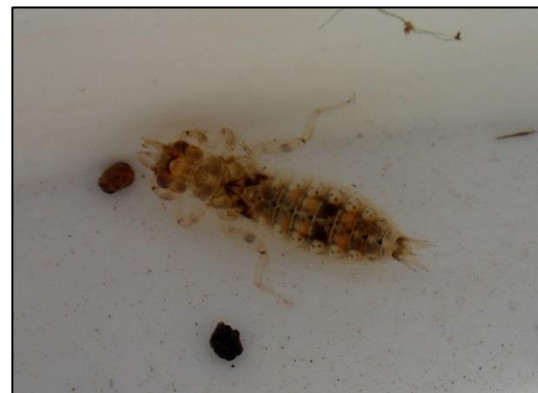
- Found in very high abundance in sandy habitats with low to high concentrations of fine sediment

Macroinvertebrate abundance	Surface sediment drupe (g/m ²) in habitat		Sensitivity score

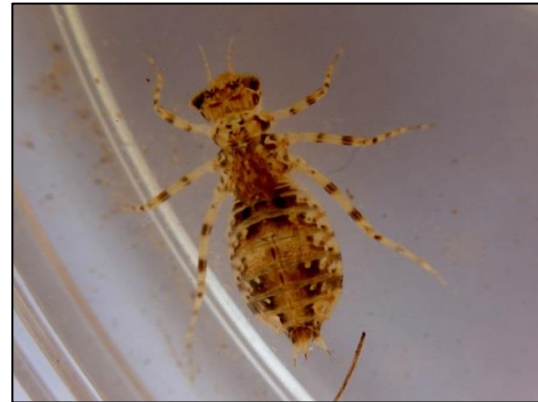
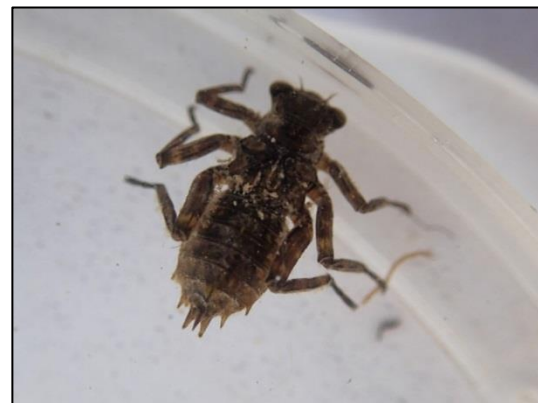
- Found in low to high concentrations of fine sediment with an increase in abundance with a decrease in fine sediment concentrations.

Macroinvertebrate abundance	Surface sediment drupe (g/m ²) in habitat		Sensitivity score

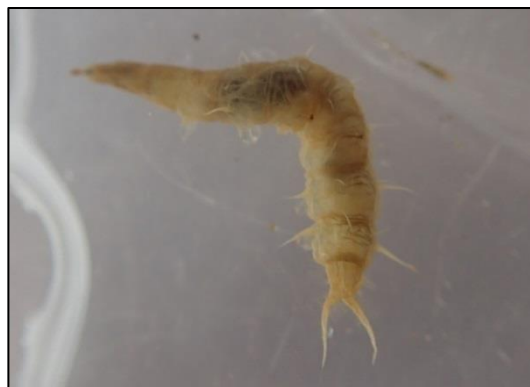
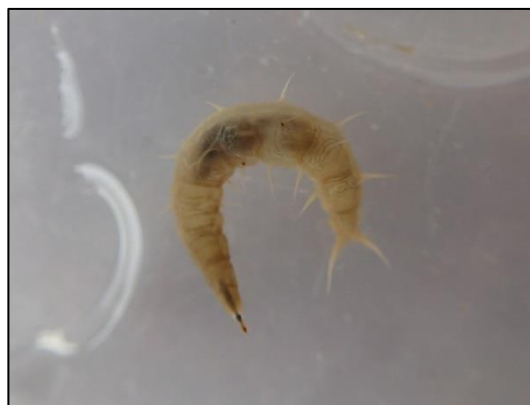
- Low abundance found in medium concentrations of fine sediment

Macroinvertebrate abundance	Surface sediment drupe (g/m ²) in habitat		Sensitivity score

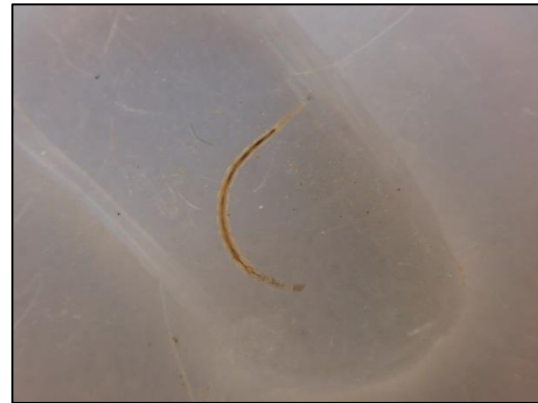
- Found in low to high concentrations of fine sediment with an increase in abundance with an increase in fine sediment concentration

Macroinvertebrate abundance	Surface sediment drupe (g/m ²) in habitat		Sensitivity score

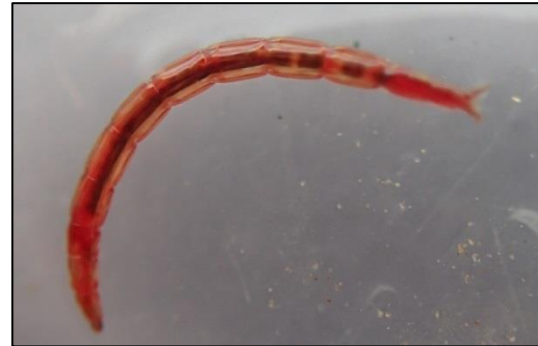
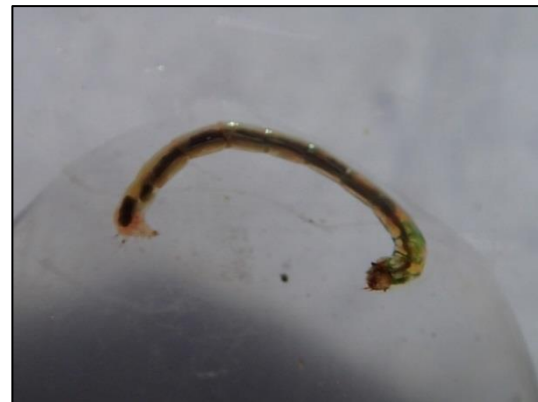
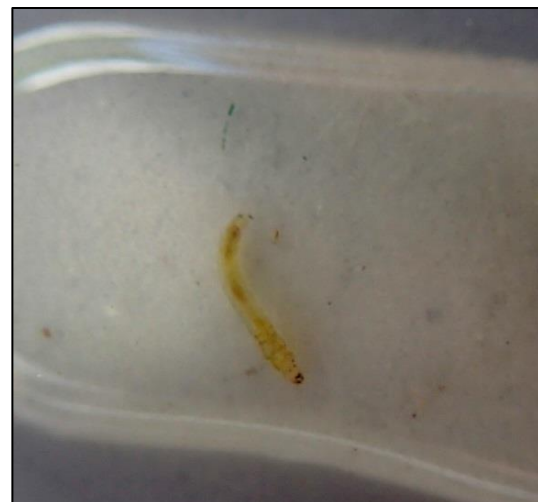
- A high abundance of Chironomidae were found with an increase in abundance with an increase in fine sediment concentration.

Macroinvertebrate abundance	Surface sediment drupe (g/m ²) in habitat		Sensitivity score

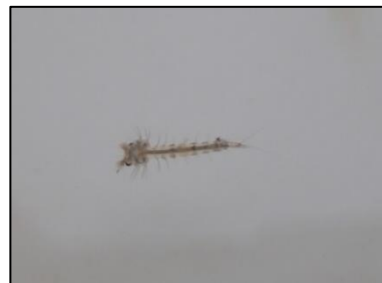
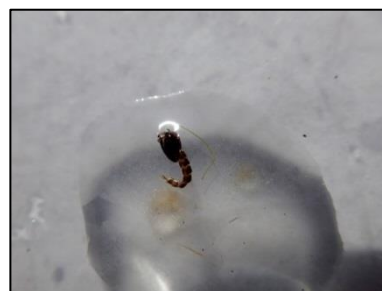
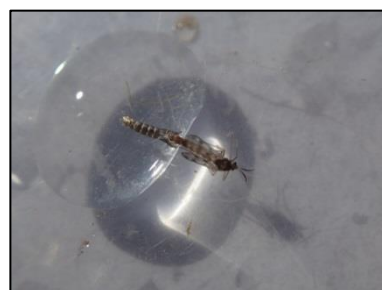
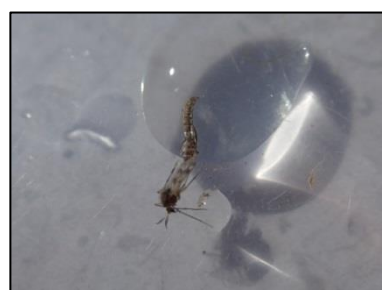
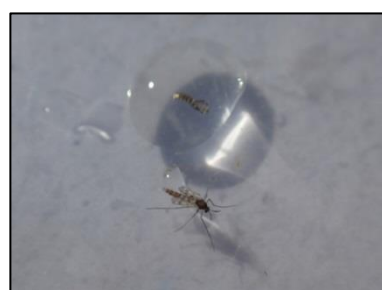
- A low abundance of Culicidae were found in low to high concentrations of fine sediment.

Macroinvertebrate abundance	Surface sediment drupe (g/m ²) in habitat		Sensitivity score

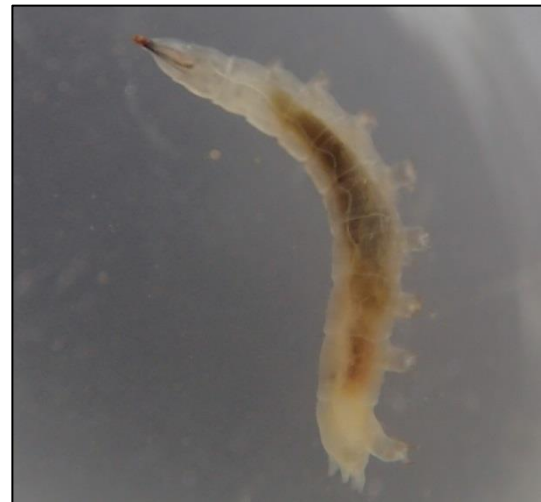
- Low abundance of Muscidae were found in low to high concentrations of fine sediment.

Macroinvertebrate abundance	Surface sediment drupe (g/m ²) in habitat		Sensitivity score

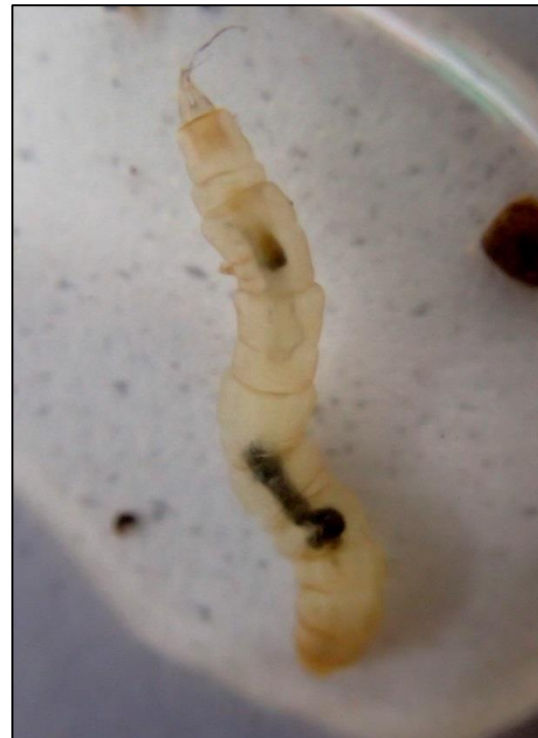
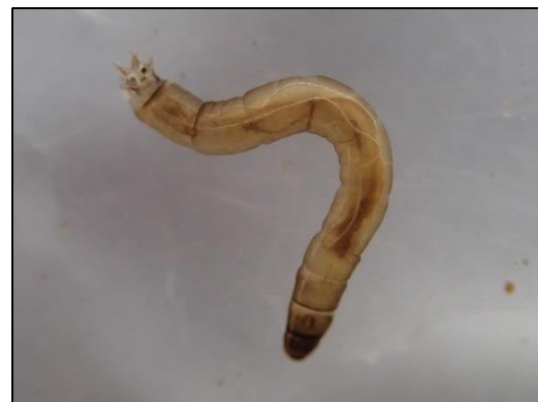
- Found in medium to high concentrations of fine sediment.

Macroinvertebrate abundance	Surface sediment drupe (g/m ²) in habitat		Sensitivity score
