# MANAGING WETLANDS IN THE UPPER TSITSA RIVER (T35 A-E)

## TSITSA PROJECT

Pippa Schlegel, Nicholas Huchzermeyer, Bennie van der Waal

2018

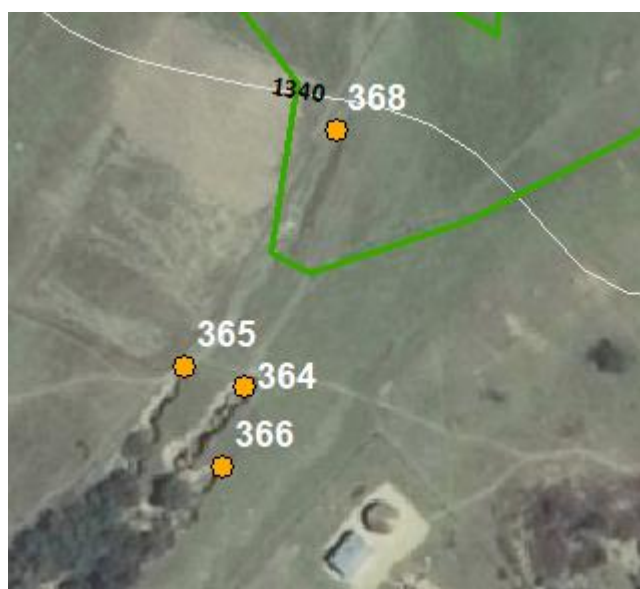
### Wetland 147

<b>Quaternary catchment</b>	<b>T35A</b>
Coordinates	-30.844 S; 28.353 E
Wetland type	Un-channelled valley bottom
Wetland area	1 ha
Degradation	Moderate
Vulnerability	High
Priority	High
Land ownership	Traditional authority
Threat	3 head-cuts encroaching the toe of the wetlands Over-grazing Alien vegetation Hydrological connectivity
Restoration needed in wetland	Head-cut control- drop inlets needed at points 364-366 Grazing management Soft options along shallow gully walls and drainage lines
Restoration needed in wetland catchment	Grazing management Alien clearing Hydrological connectivity

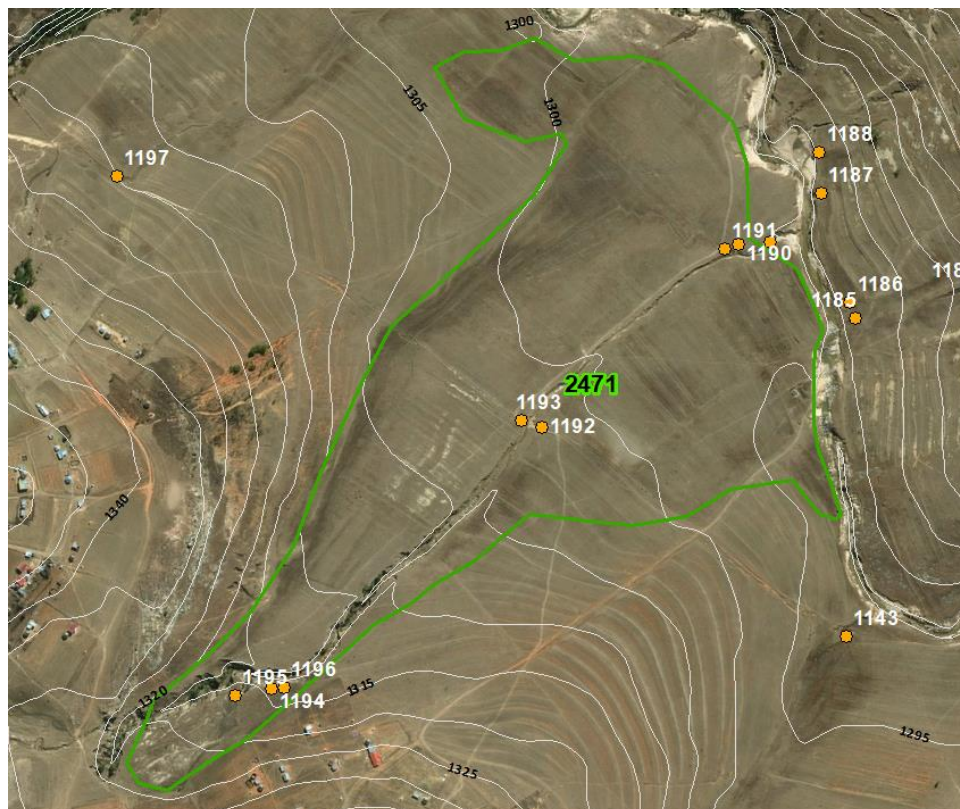
## Wetland 2471

<b>Quaternary catchment</b>	<b>T35A</b>
Coordinates	-30.898 S; 28.409 E
Wetland type	Un-channelled valley bottom
Wetland area	5 ha
Degradation	Moderate
Vulnerability	Moderate
Priority	Moderate
Land ownership	Traditional
Threat	Headward gully erosion, agriculture, livestock paths Over-grazing Abandoned cultivated fields Increased hydrological connectivity in catchment
Restoration needed in wetland	Grazing management Livestock crossings through wetland Re-vegetate abandoned cultivated fields Soft structures and re-sloping along shallow erosional features
Restoration needed in wetland catchment	Grazing management Decreased hydrological connectivity related to livestock track runoff and bare fields Alien vegetation clearing Road run-off management

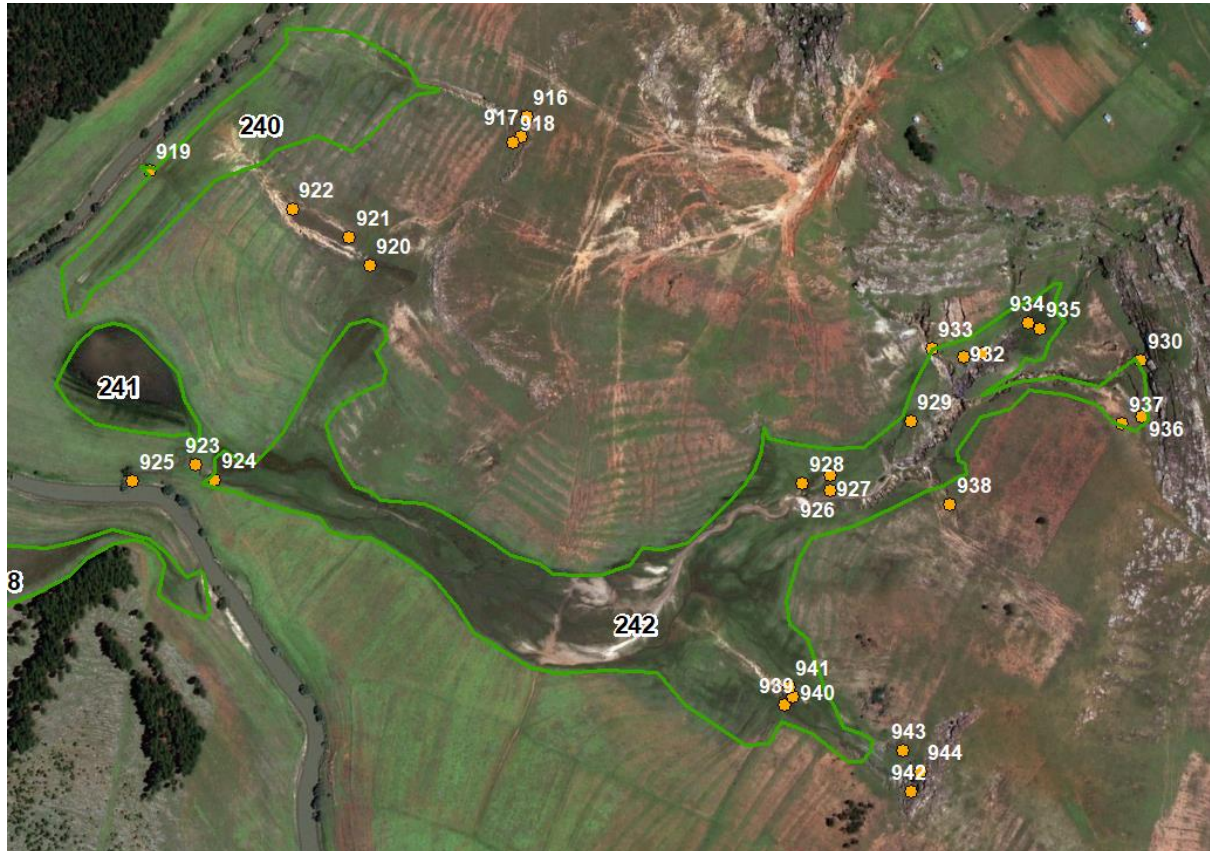
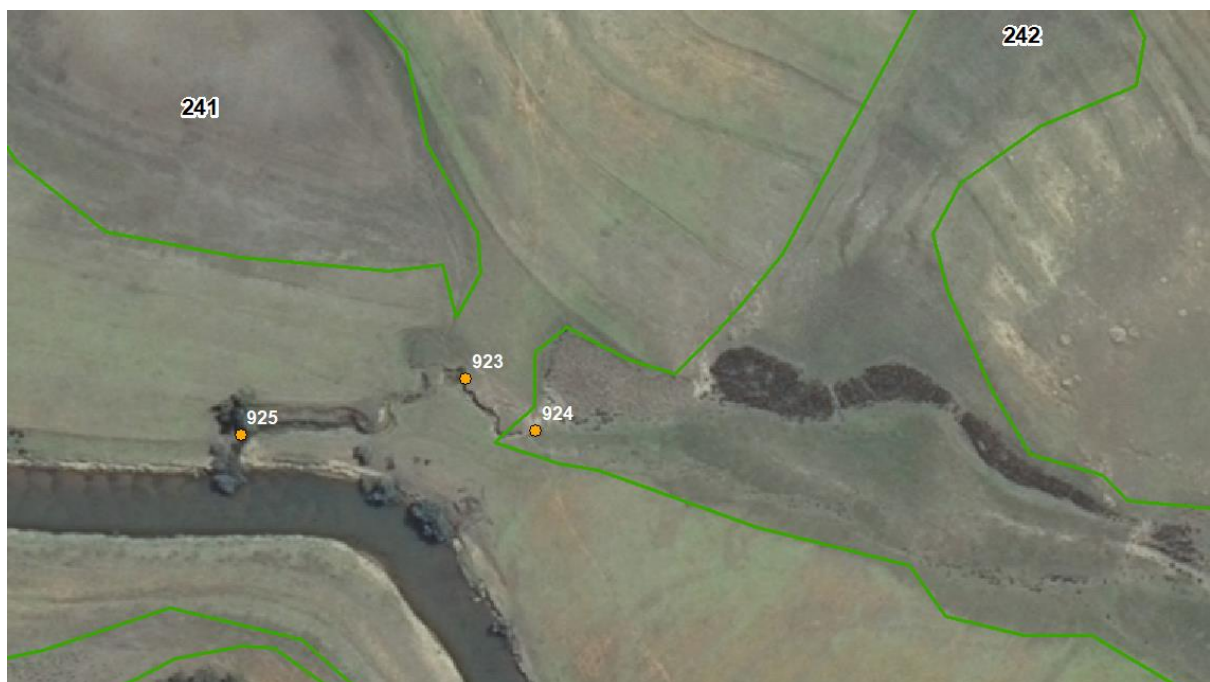
## Wetland 242

Quaternary catchment	T35A
Coordinates	-30.939 S; 28.409 E
Wetland type	Un-channelled valley bottom
Wetland area	12.9 ha
Degradation	Mod
Vulnerability	High
Priority	Mod
Land ownership	Traditional
Threat	Headcut erosion, agriculture, livestock paths Over-grazing Abandoned cultivated fields Increased hydrological connectivity in catchment
Restoration needed in wetland	Headcut control Point 924 Grazing management Livestock crossings through wetland Soft structures and re-sloping along shallow erosional features
Restoration needed in wetland catchment	Grazing management Decreased hydrological connectivity related to livestock track runoff Alien vegetation clearing

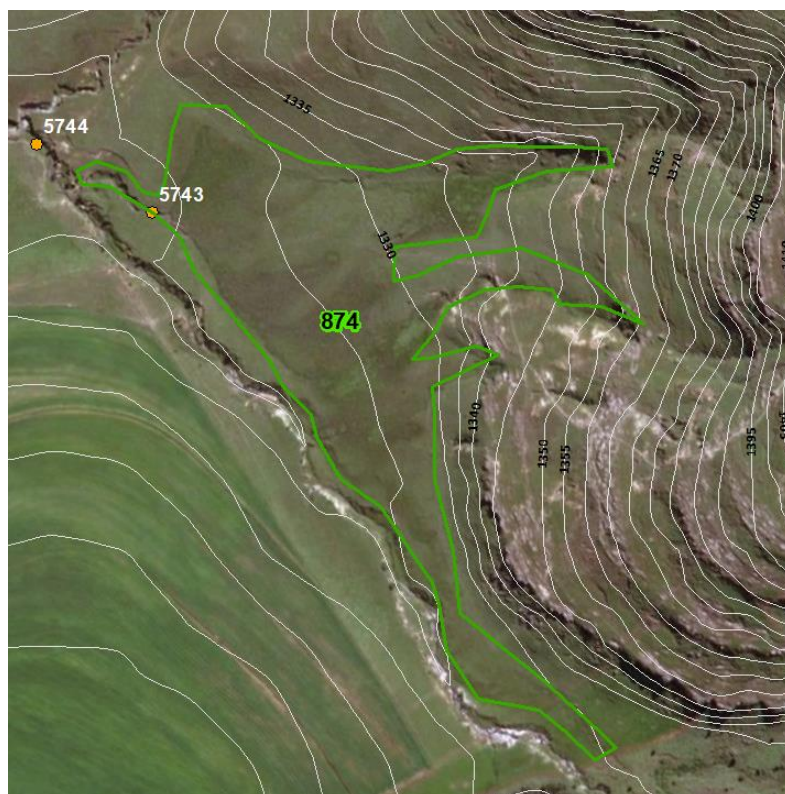
## Wetland 874

Quaternary catchment	T35C
Coordinates	-31.059 S; 28.241 E
Wetland type	Un-channelled valley bottom
Wetland area	5 ha
Degradation	Moderate
Vulnerability	High
Priority	High
Land ownership	Private
Threat	Headward gully erosion, Increased hydrological connectivity in catchment
Restoration needed in wetland	Headcut control structure at 5743 Soft structures and re-sloping along shallow erosional features
Restoration needed in wetland catchment	Decreased hydrological connectivity

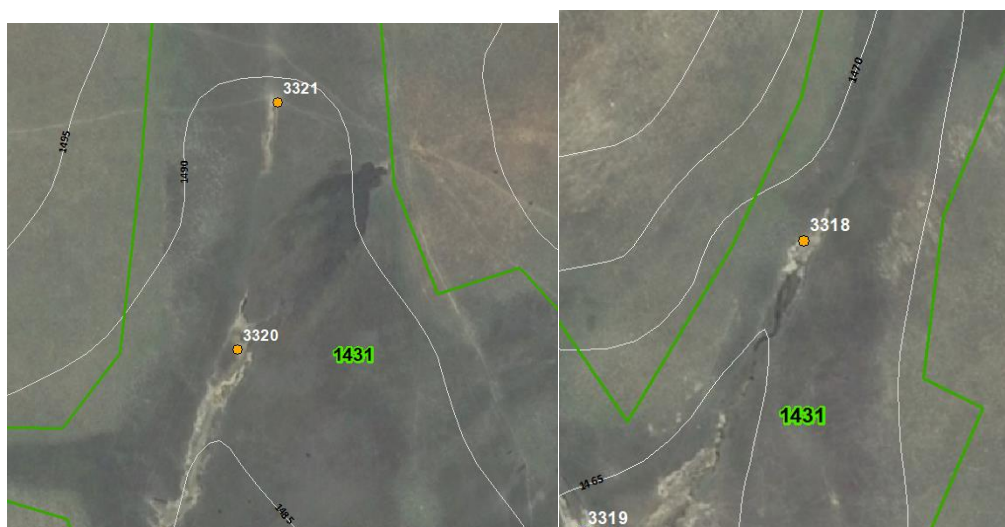
### Wetland 1431

Quaternary catchment	T35D
Coordinates	-30.918 S; 28.549 E
Wetland type	Un-channelled valley bottom
Wetland area	44 ha
Degradation	Moderately
Vulnerability	Moderate
Priority	High
Land ownership	Traditional boundary-
Threat	Incised channel, road runoff Over-grazing Increased hydrological connectivity in catchment
Restoration needed in wetland	Baselevel control structure at Point 3321 and 3318. Revegetate abandoned fields Grazing management Livestock crossings through wetland Soft structures and re-sloping along shallow erosional features
Restoration needed in wetland catchment	Grazing management Decreased hydrological connectivity related to road and livestock track runoff AIP management

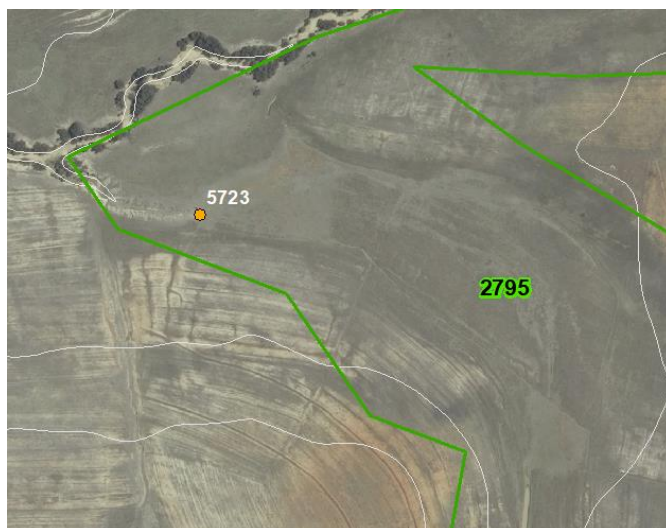
### Wetland 2795

Quaternary catchment	T35D
Coordinates	-30.944 S; 28.526
Wetland type	Un-channelled valley bottom
Wetland area	106.9 ha
Degradation	Moderate
Vulnerability	High
Priority	Moderate
Land ownership	Traditional
Threat	Agricultural drains, headward gully erosion Over-grazing Increased hydrological connectivity in catchment
Restoration needed in wetland	Headcut control structure at Point 5723 and Grazing management Livestock crossings through wetland Soft structures and re-sloping along shallow erosional features
Restoration needed in wetland catchment	Grazing management Decreased hydrological connectivity related to road and livestock track runoff AIP management

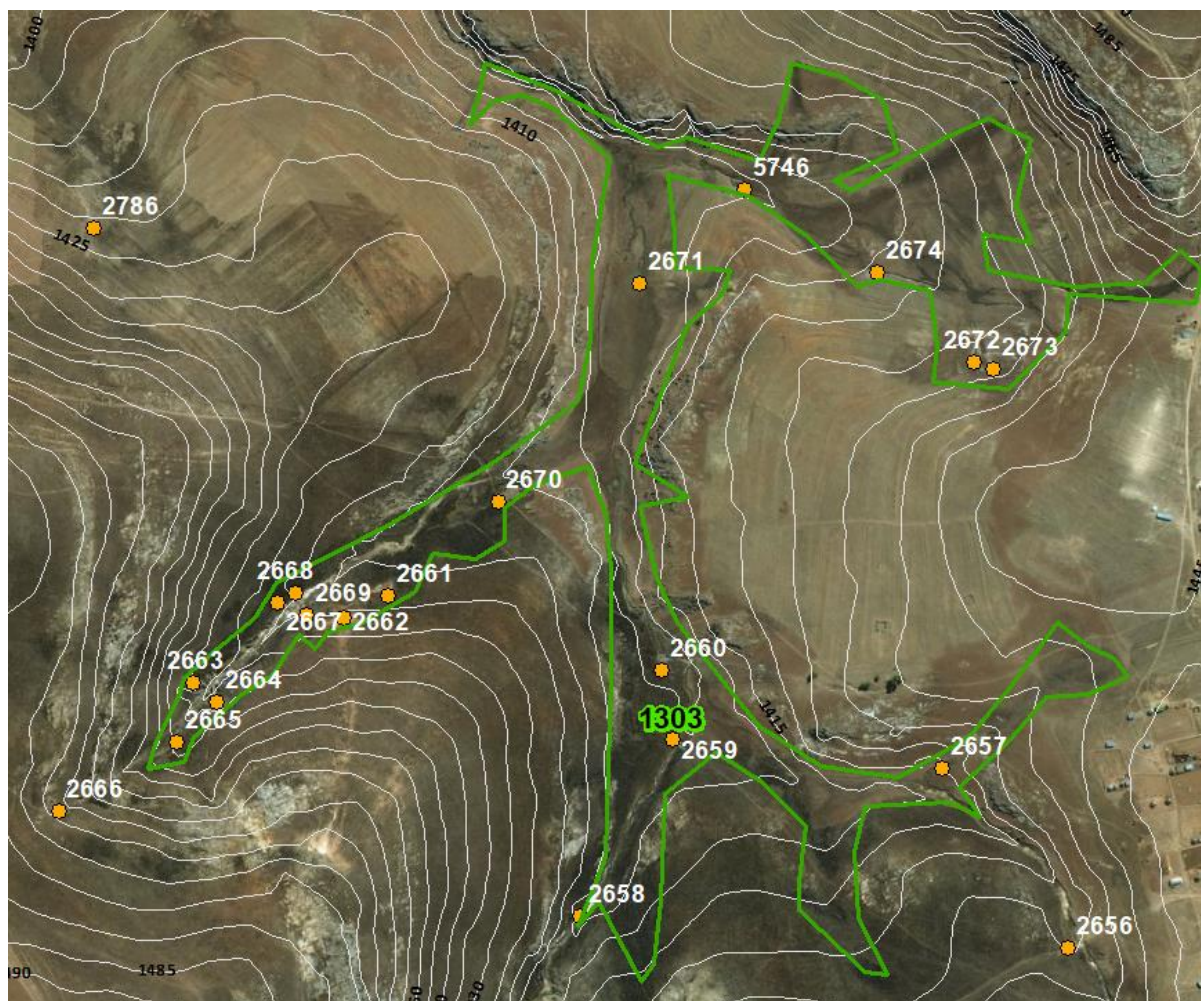
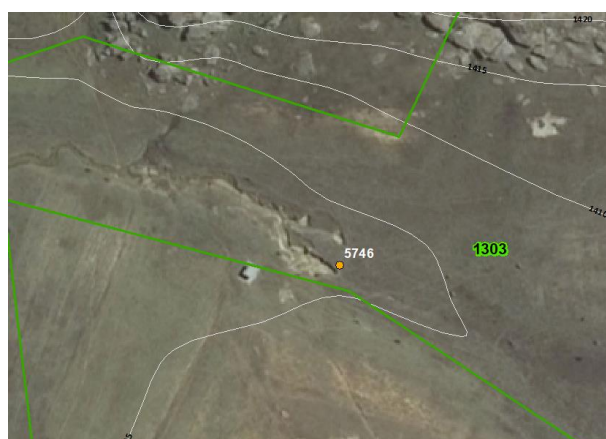
## Wetland 1303

Quaternary catchment	T35D
Coordinates	-31.009 S; 28.542 E
Wetland type	Un-channelled valley bottom
Wetland area	35 ha
Degradation	Moderate
Vulnerability	High
Priority	High
Land ownership	Traditional
Threat	Headward gully erosion, agriculture, road run-off, livestock paths Over-grazing Abandoned cultivated fields Increased hydrological connectivity in catchment
Restoration needed in wetland	Headcut control structure Point 5746 Grazing management Livestock crossings through wetland Re-vegetate abandoned cultivated fields Soft structures and re-sloping along shallow erosional features
Restoration needed in wetland catchment	Grazing management Decreased hydrological connectivity related to livestock track runoff and bare fields Alien vegetation clearing Road run-off management

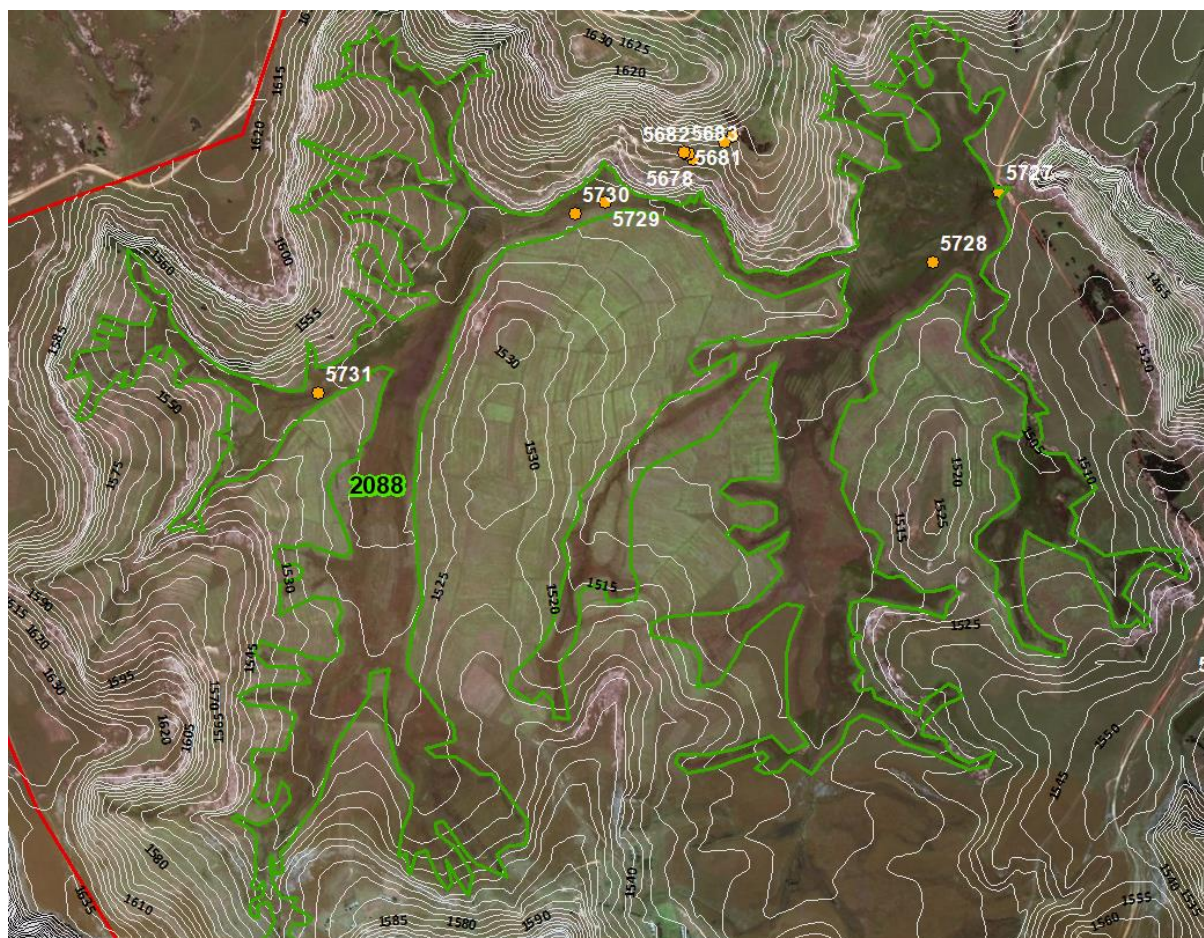
## Wetland 2088

<b>Quaternary catchment</b>	<b>T35E</b>
Coordinates	-30.943 S; 28.611 E
Wetland type	Un-channelled valley bottom
Wetland area	261 ha
Degradation	Moderate
Vulnerability	Low
Priority	Moderate
Land ownership	Traditional
Threat	Agricultural drains, headward gully erosion, road run-off Over-grazing Alien Vegetation Increased hydrological connectivity in catchment
Restoration needed in wetland	Base level control structure at Point 5727 and 5729 Grazing management Livestock crossings through wetland Soft structures and re-sloping along shallow erosional features
Restoration needed in wetland catchment	Grazing management Decreased hydrological connectivity related to road and livestock track runoff AIP management

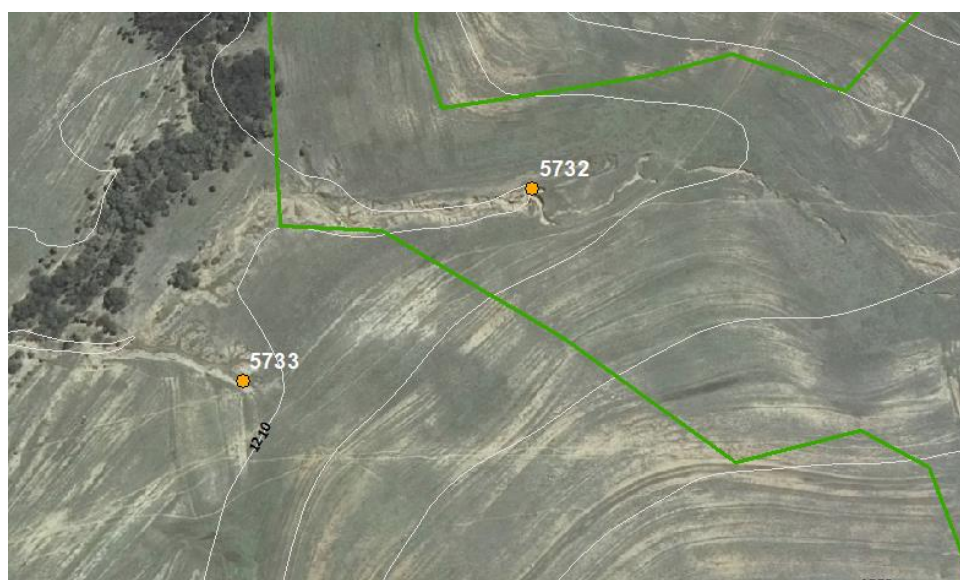
## Wetland 2004

Quaternary catchment	T35E
Coordinates	-30.985 S; 28.695 E
Wetland type	Un-channelled valley bottom
Wetland area	42 ha
Degradation	Moderate
Vulnerability	Moderate
Priority	Moderate
Land ownership	Traditional
Threat	Headward gully erosion, agriculture, road run-off Over-grazing Increased hydrological connectivity in catchment
Restoration needed in wetland	Headcut control structure at Point 5732 Grazing management Livestock crossings through wetland Re-vegetate abandoned cultivated fields Soft structures and re-sloping along shallow erosional features
Restoration needed in wetland catchment	Grazing management Decreased hydrological connectivity related to livestock track runoff and bare fields Alien vegetation clearing Road run-off management

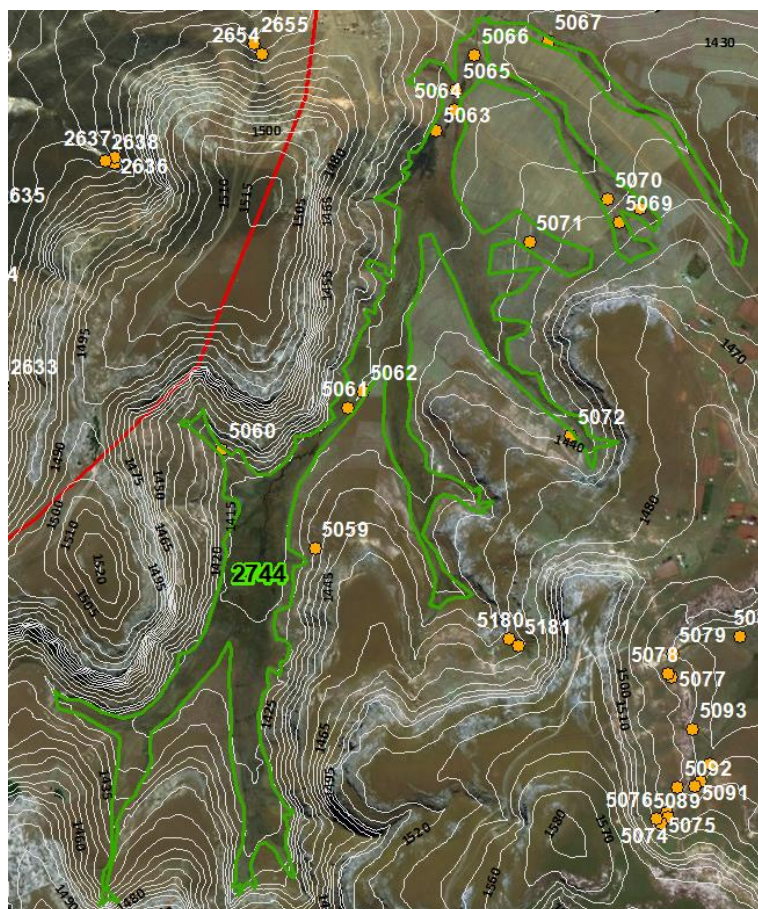
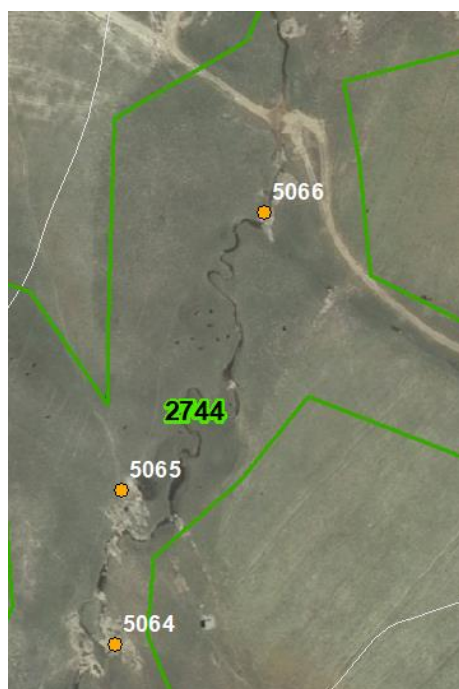
## Wetland 2744

Quaternary catchment	T35E
Coordinates	-31.022 S; 28.556 E
Wetland type	Un-channelled valley bottom
Wetland area	81 ha
Degradation	Moderate
Vulnerability	High
Priority	Moderate
Land ownership	Traditional
Threat	Headward gully erosion, road run-off, agriculture Over-grazing Increased hydrological connectivity in catchment
Restoration needed in wetland	Base level control structure below Point 5066, possibly base level control structure upstream Point 5061 Headcut control structure Point 5067 Grazing management Livestock crossings through wetland Re-vegetate abandoned cultivated fields Soft structures and re-sloping along shallow erosional features
Restoration needed in wetland catchment	Grazing management Decreased hydrological connectivity related to livestock track runoff Re-vegetate abandoned cultivated fields
