MANAGING SMALL RESERVOIRS IN THE UPPER TSITSA CATCHMENT

Catchment T35 A-E Prioritisation Plan

TSITSA PROJECT

December 2018

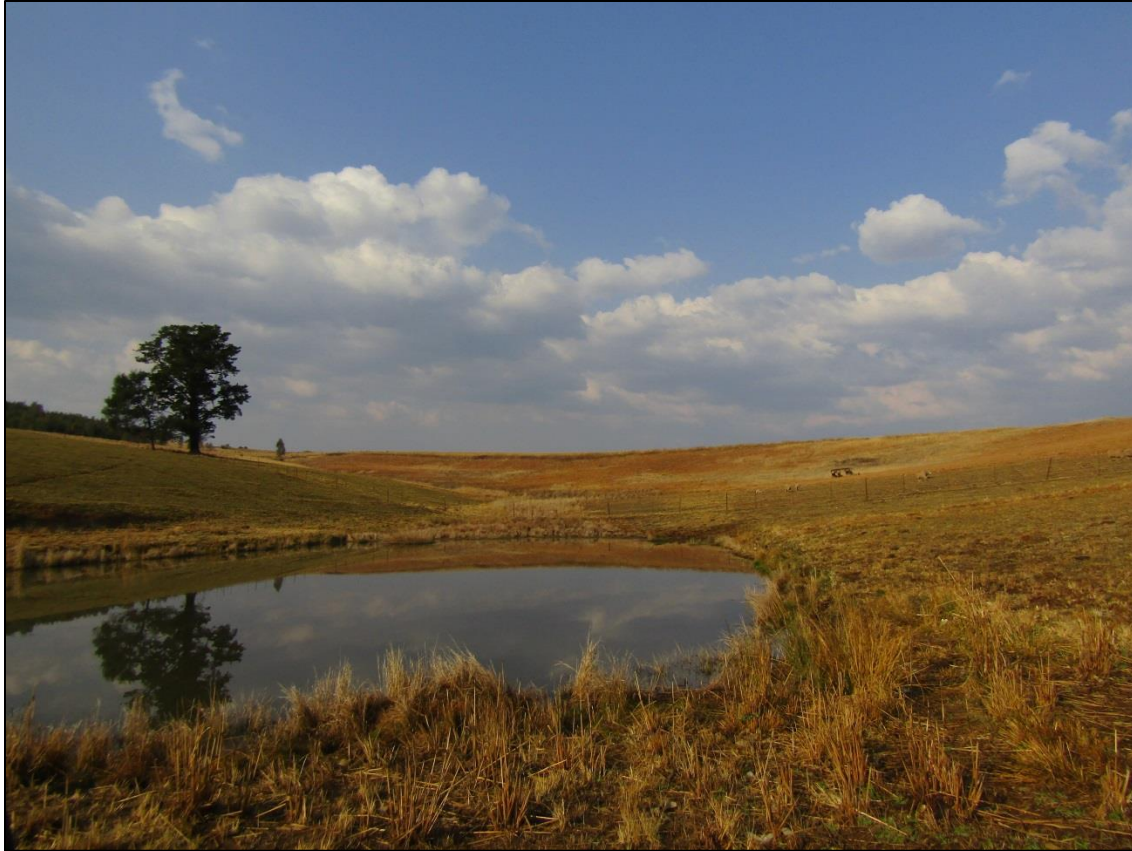
Figure 1: A dam and catchment exhibiting low vulnerability to erosion

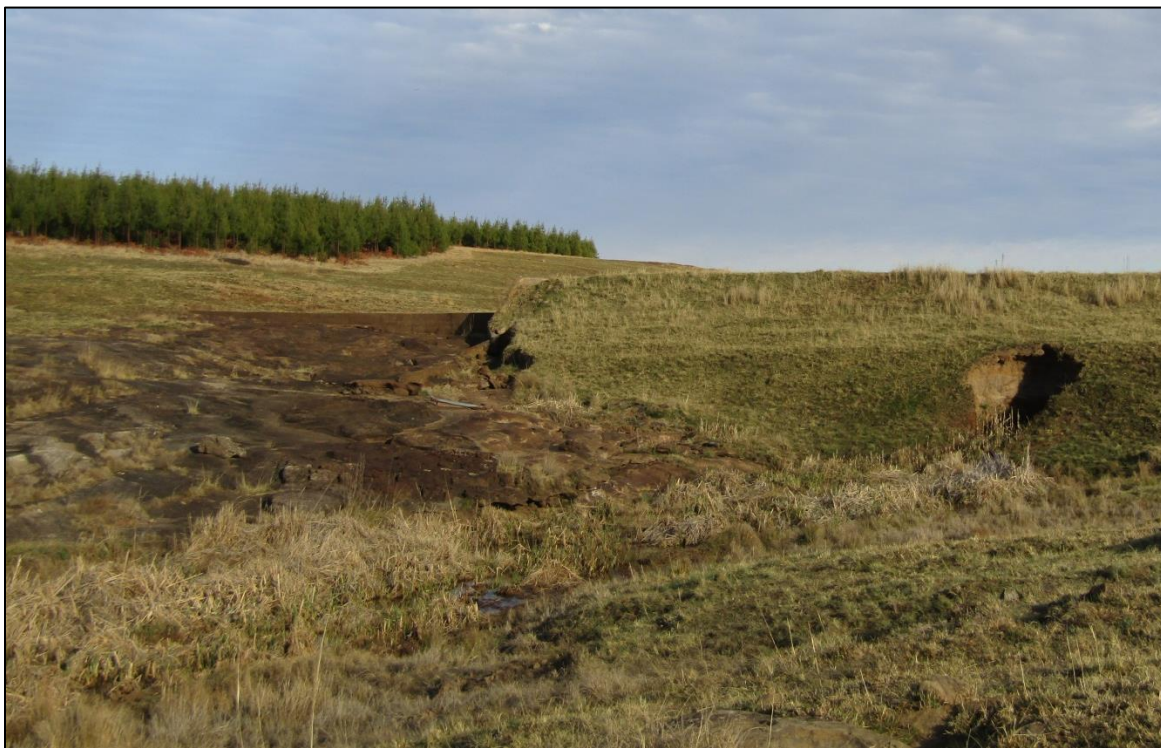
Figure 2: A dam exhibiting an erosional nick point on the dam wall which could result in dam wall breaching

Those dams vulnerable to erosion/breaching will require attention in order to maintain their function to support livelihoods and trap sediment. This will be site-specific, but is likely to include gully head stabilisation, revegetation of bare areas, soil treatment, and soil compaction where the dam wall is showing signs of erosion.

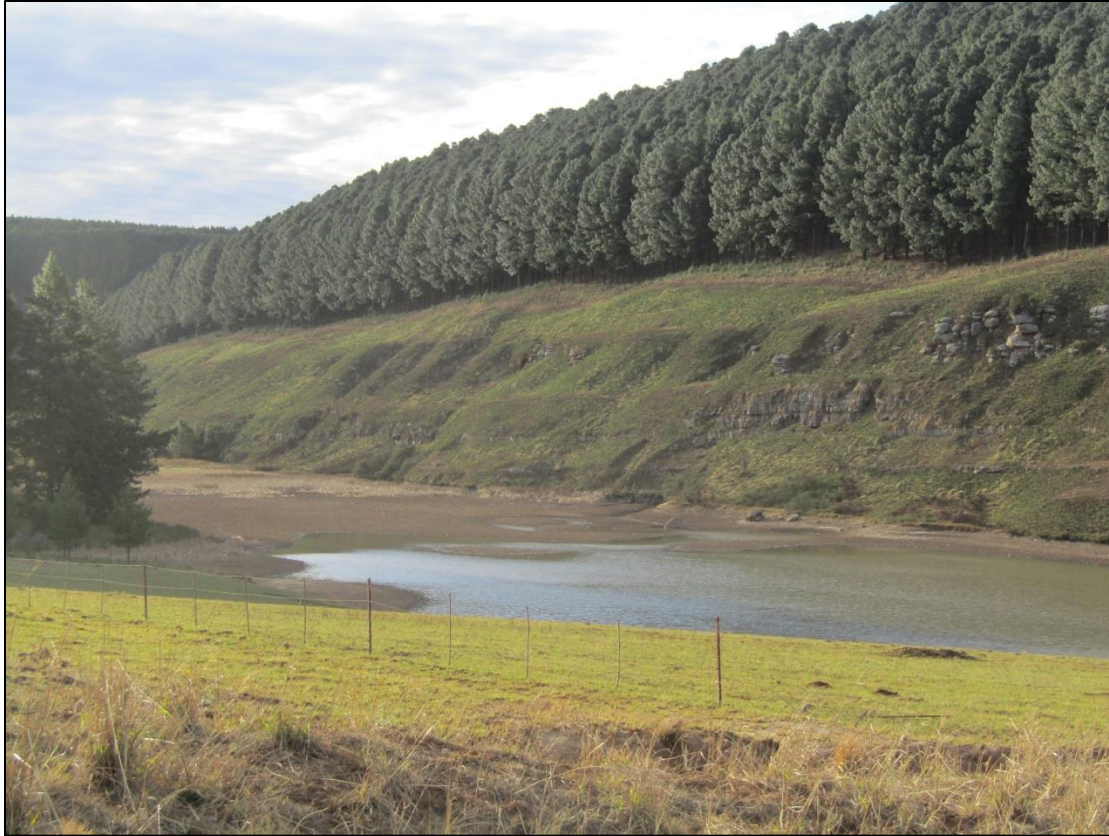
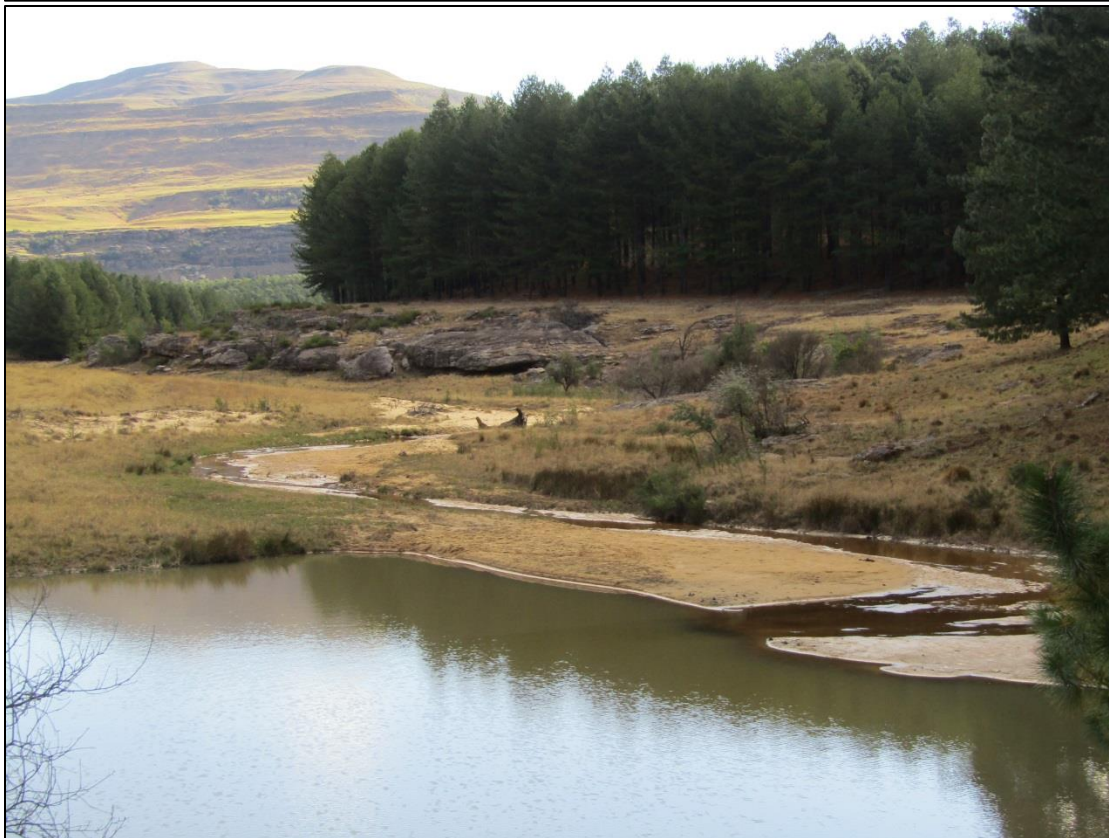
Figure 3: Dams acting as sediment traps

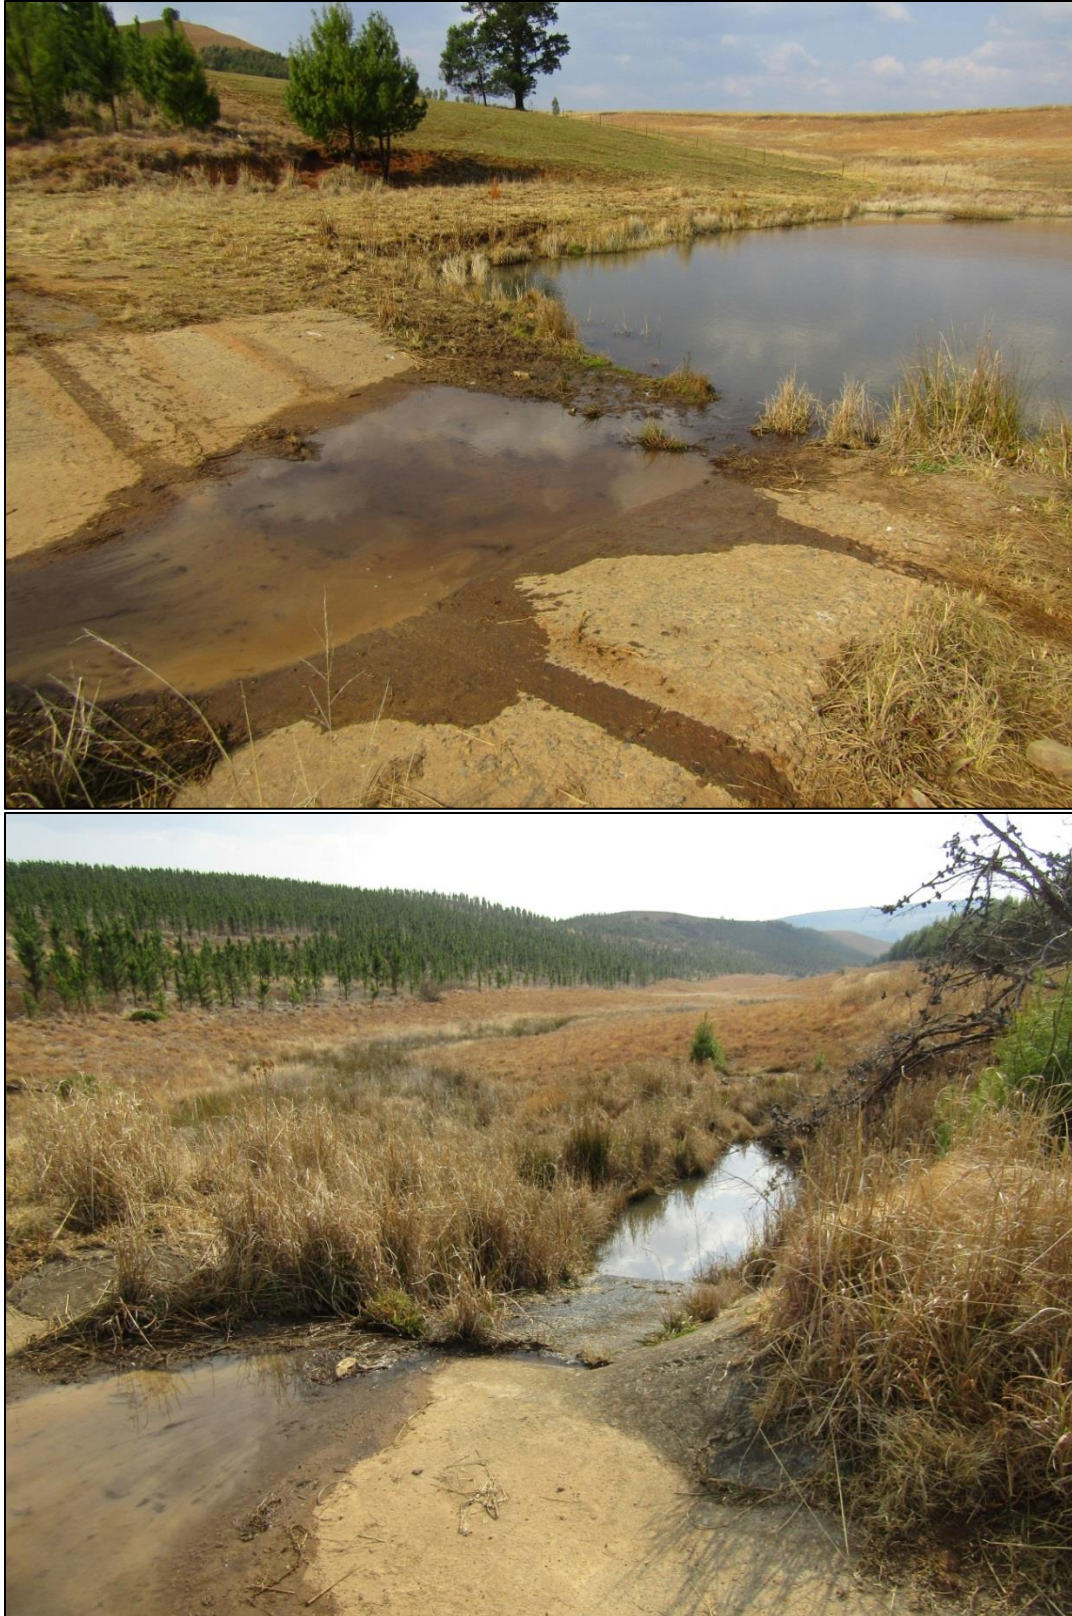
Figure 4: A well maintained and vegetated spillway
